Blueprint Home Inspection

Home Inspection Report

5309 Easy St

Inspected on Sat, Aug 1 2020 at 1:00 PM

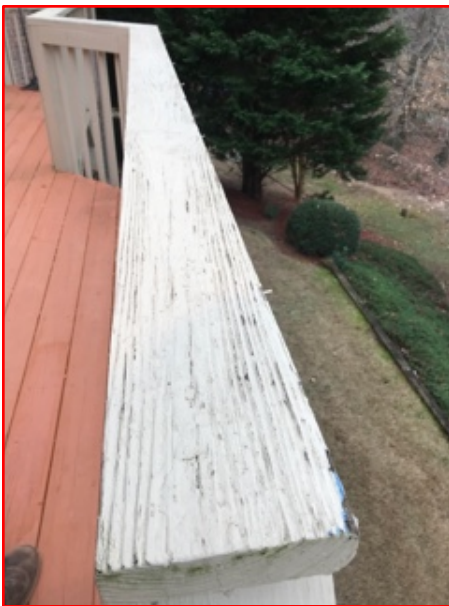
Figure 4-1

1) Comment 4: The paint on the handrail is beginning to deteriorate. I would recommend a fresh coat to seal up the wood fibers and prevent moisture damage.

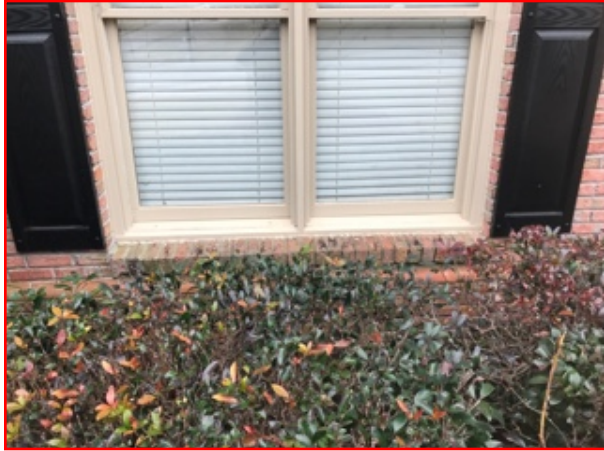
Figure 5-1

2) Comment 5: There are several places around the exterior of the home that need to be repaired, caulked and repainted. Some of the windows have been repaired but further repairs are needed in areas. I would recommend further evaluation and repair by a painting contractor.

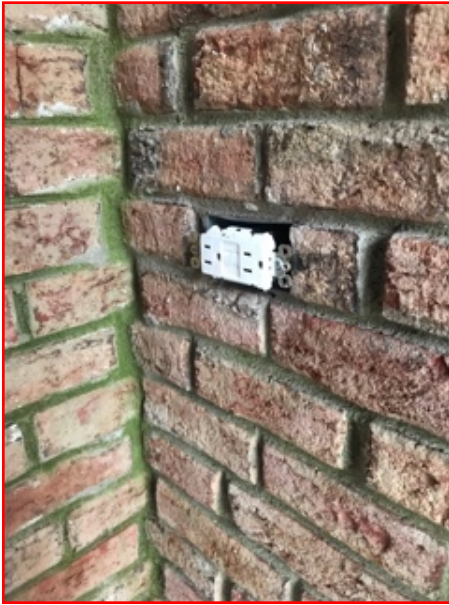
Figure 6-1

3) Comment 6: The outlet on the patio is missing the weatherproof cover.

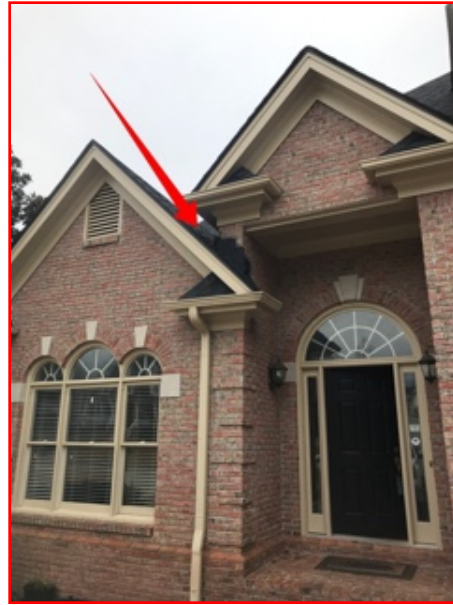
Figure 8-2

5) Comment 8: There is a small section of roof above the front door that has collected leaves and debris. I would have this cleaned out.

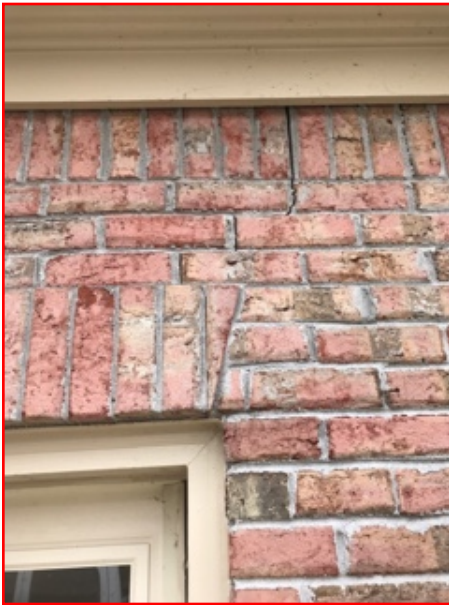
Figure 9-1

6) Comment 9: There is a crack in the brick above one of the garage doors. The crack does not present a structural concern, but it should be sealed up.

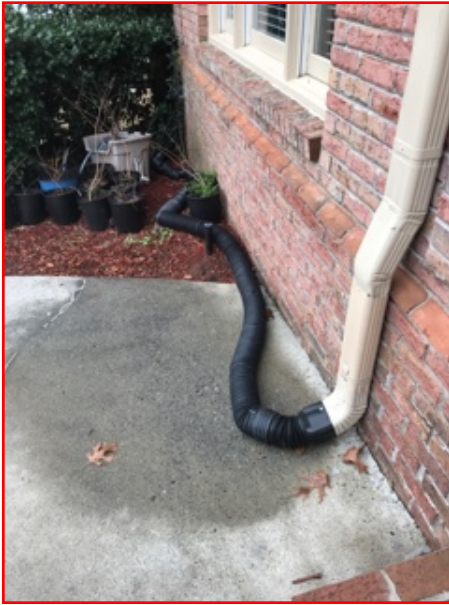
Figure 10-1

7) Comment 10: There is a gutter pipe near the front door that extends around the left side of the house. The drainage pipe is crushed which will impede the flow of water. I would have the drainage pipe replaced.

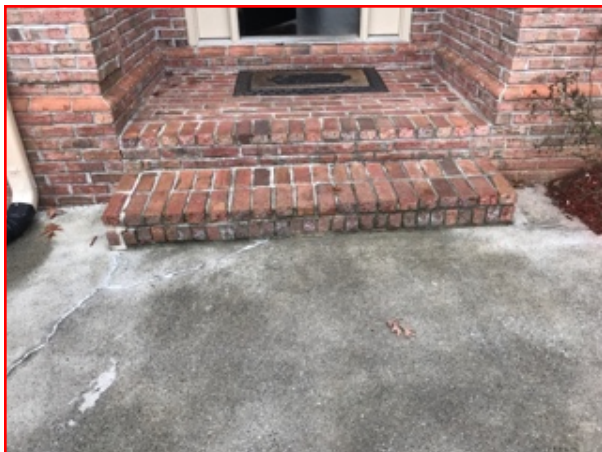
Figure 11-1

8) Comment 11: The steps at the front door are out of level. Some of the mortar on the left side needs to be repointed to prevent water from getting into the step. In the wintertime this water will freeze and cause further damage.

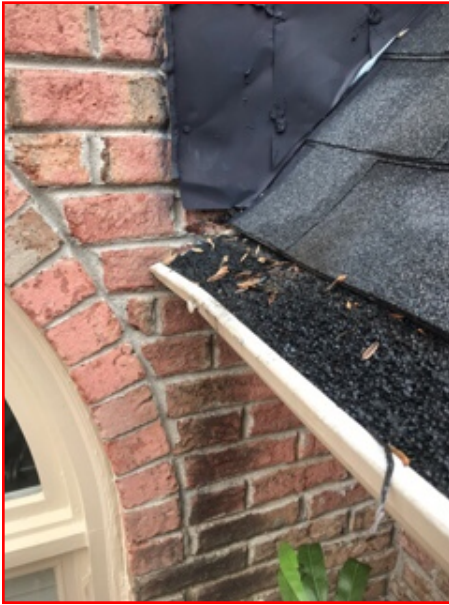
Figure 12-1

9) Comment 12: There is a stain on the brick, on the deck. The stain indicates that water is leaking behind the gutter and running down the face of the brick. I would have a kick out flashing installed to divert the water into the gutter.

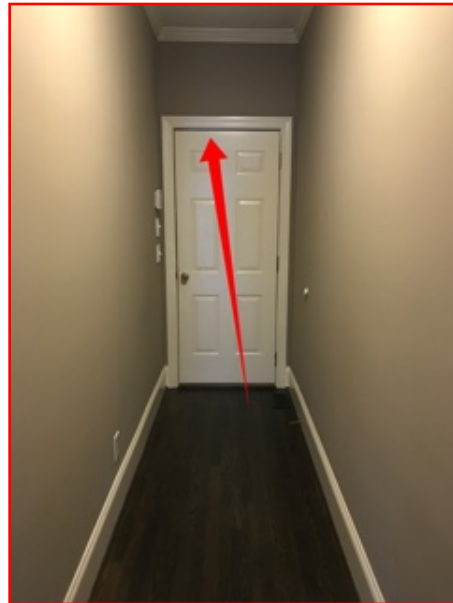
Figure 13-2

10) Comment 13: The door leading into the garage does not seal well against the weatherstripping at the top. I would add additional weatherstripping or adjust the door so that it seals correctly.

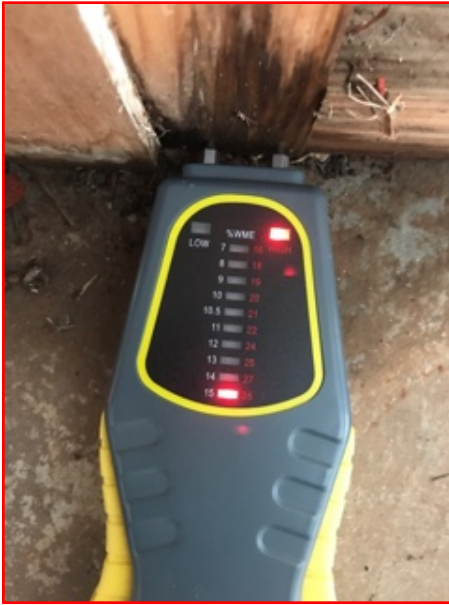
Figure 14-1

11) Comment 14: There is evidence of moisture intrusion between the garage doors. I would have the exterior of the door and weatherstripping sealed correctly.

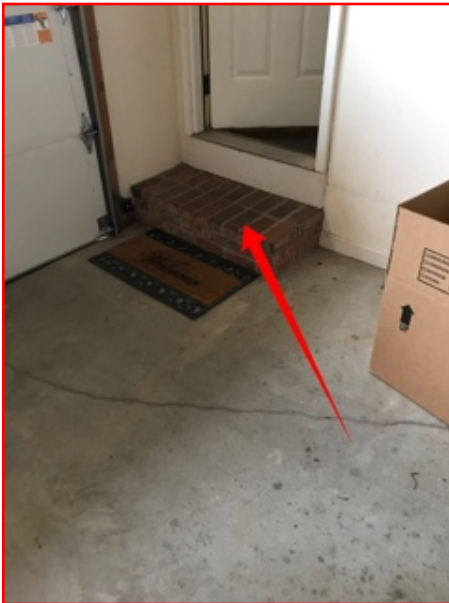
Figure 15-1

12) Comment 15: The step from the garage into the house is loose. You may be able to carefully raise the step and add an adhesive under it.

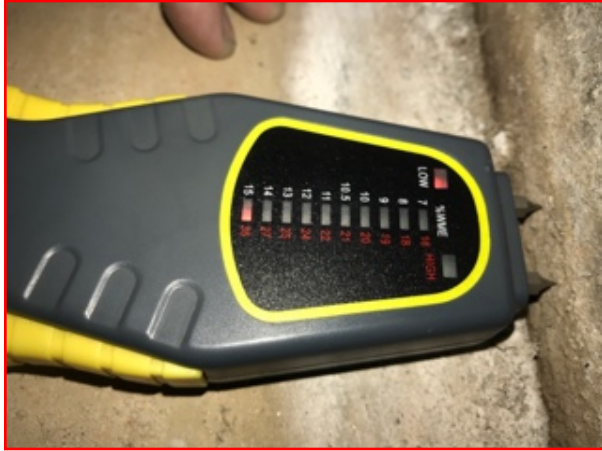
Figure 16-1

13) Comment 16: There are 3 foundation leaks in the basement. The moisture reading in the areas are higher than the adjacent surfaces. I would recommend further evaluation and correction by a qualified contractor.

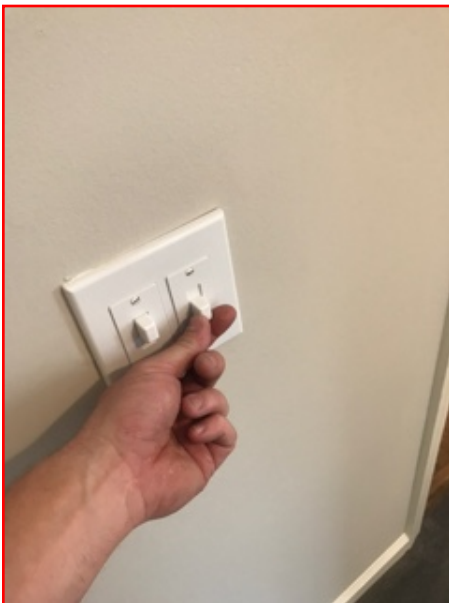
Figure 20-1

14) Comment 20: The fan switch in the front right bedroom is difficult to operate. The switch works but you might consider having it replaced.

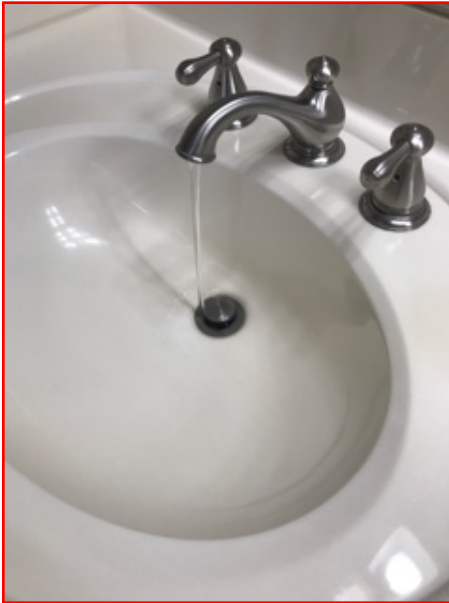
Figure 25-1

15) Comment 25: The water pressure drops off significantly when multiple fixtures are being used. This may indicate that the pressure reducing valve is going bad. I would recommend further evaluation and correction by a plumber.

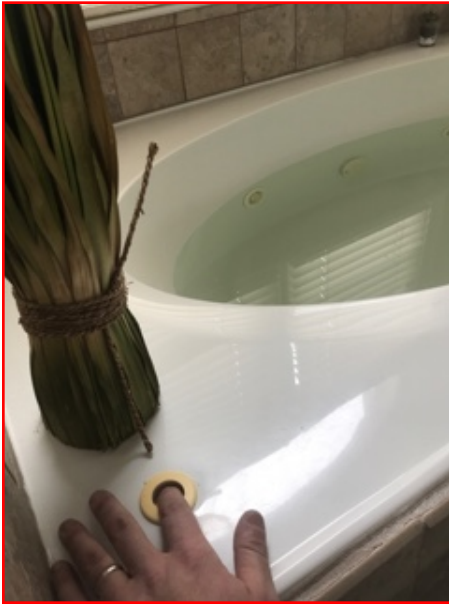
Figure 28-1

16) Comment 28: The motor on the garden tub would not come on. The switch and GFCI for the tub are located behind the door in the toilet cubby. I would recommend further evaluation and repair by an electrician.

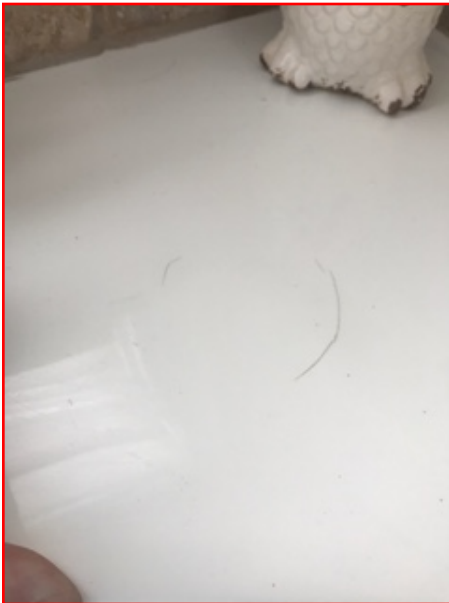
Figure 29-1

17) Comment 29: There is a small crack in the tub deck. TnT Bathtub Repair in Bethlehem does these kind of repairs.

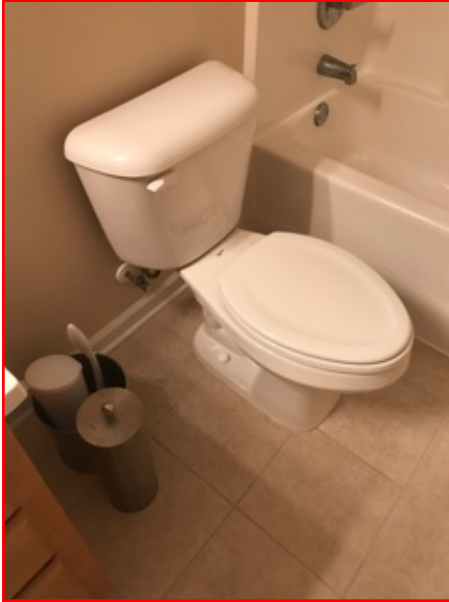
Figure 30-1

18) Comment 30: The toilet in the basement refills very slowly. I would recommend having a new fill valve installed.

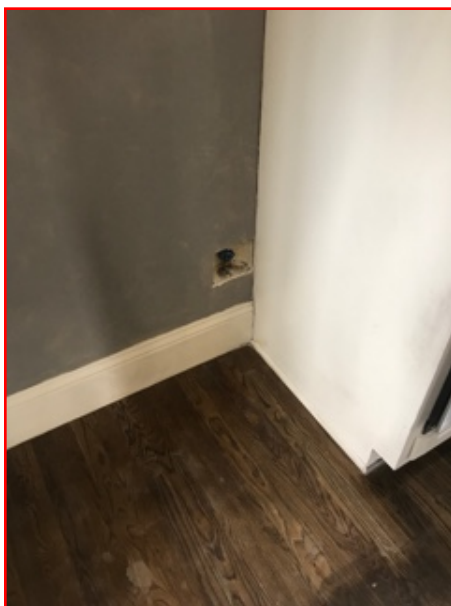
Figure 32-1

20) Comment 32: The trim plate is missing from the ice maker box.

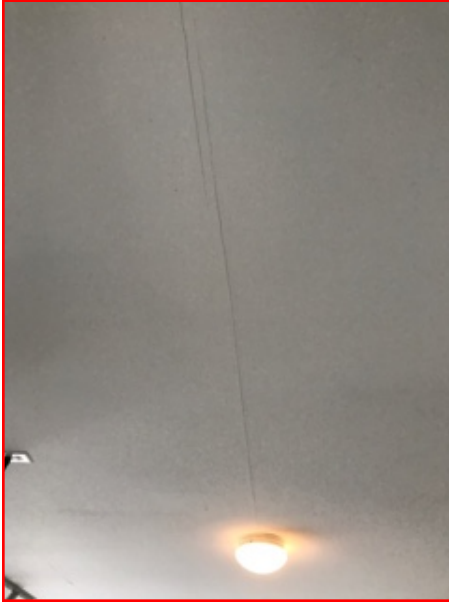
Figure 34-1

22) Comment 34: There are several places in the interior of the home where the drywall needs to be repaired and re-painted.

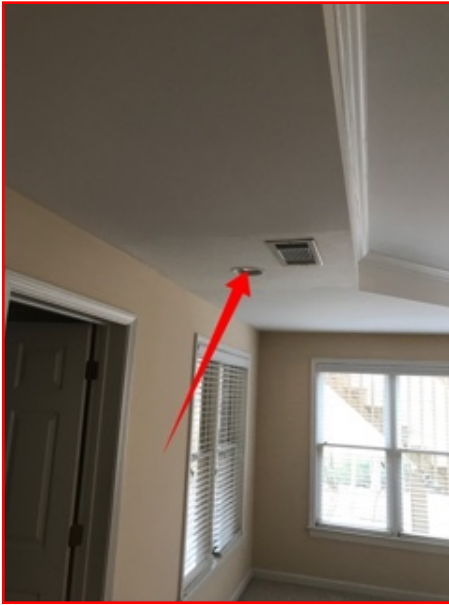
Figure 36-1

24) Comment 36: A repair has been made to the drywall in one of the downstairs rooms. There is no apparent moisture in the area so I would ask the current owners for an explanation.

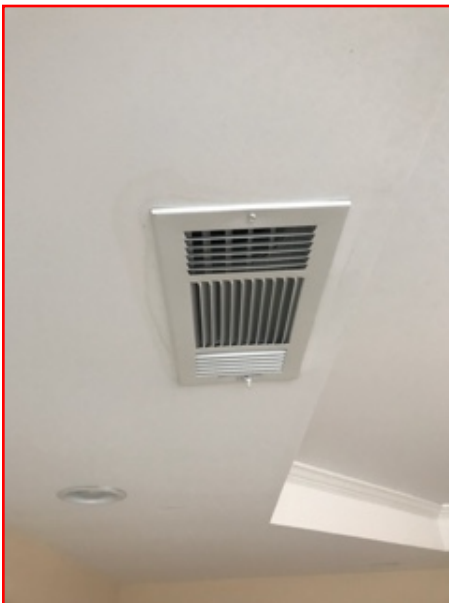
Figure 37-1

25) Comment 37: There are a couple of water stains on the ceiling under the kitchen sink. There was no apparent moisture in the area at the time of inspection. I would ask the current owners for an explanation.

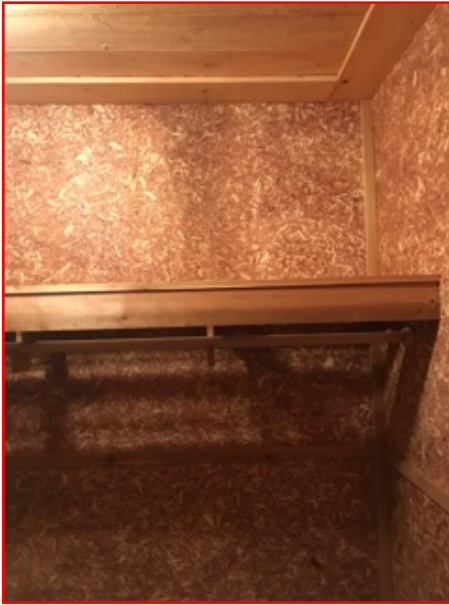
Figure 38-1

26) Comment 38: There are some water stains in the small room under the master shower. The moisture content of the wood is slightly higher in the stained area. Further evaluation and repair is needed.

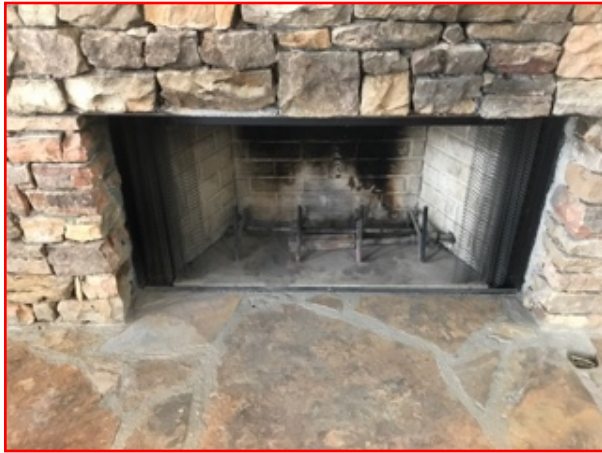
Figure 39-1

27) Comment 39: The fireplace is a manufactured unit which includes a gas starter. The rear panel has some small cracks and needs to be replaced. The damper is operational and the flue appears to be fairly clean. It is recommended to have the fireplace and flue pipe cleaned and inspected every 12 months. I would recommend having this done prior to closing.

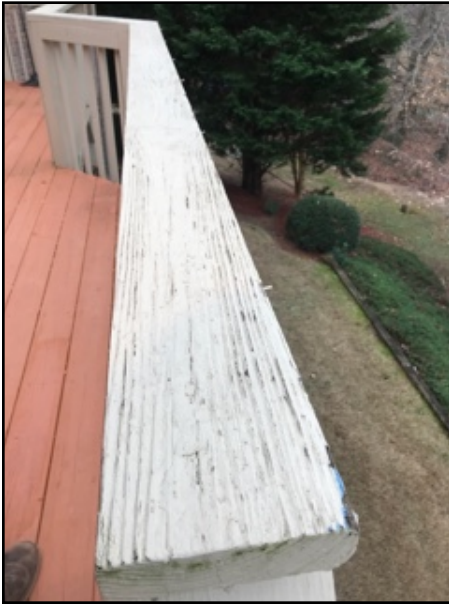
Figure 4-1

The paint on the handrail is beginning to deteriorate. I would recommend a fresh coat to seal up the wood fibers and prevent moisture damage.

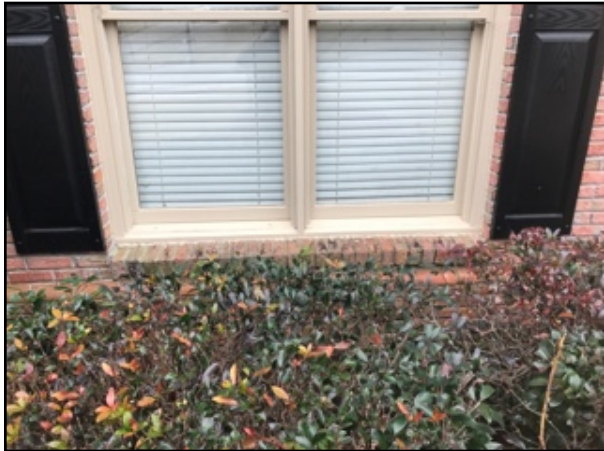
Figure 5-1

There are several places around the exterior of the home that need to be repaired, caulked and repainted. Some of the windows have been repaired but further repairs are needed in areas. I would recommend further evaluation and repair by a painting contractor.

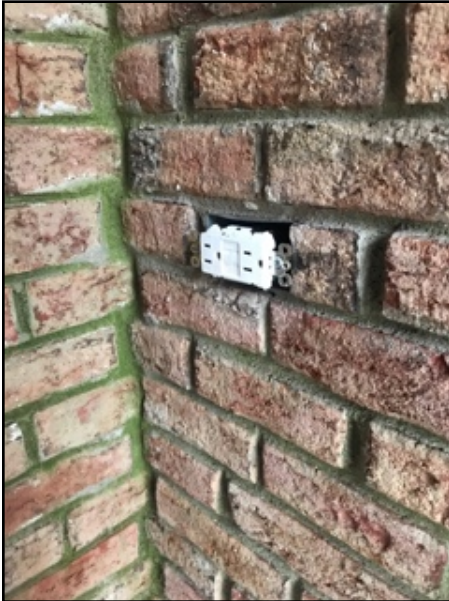
Figure 6-1

The outlet on the patio is missing the weatherproof cover.

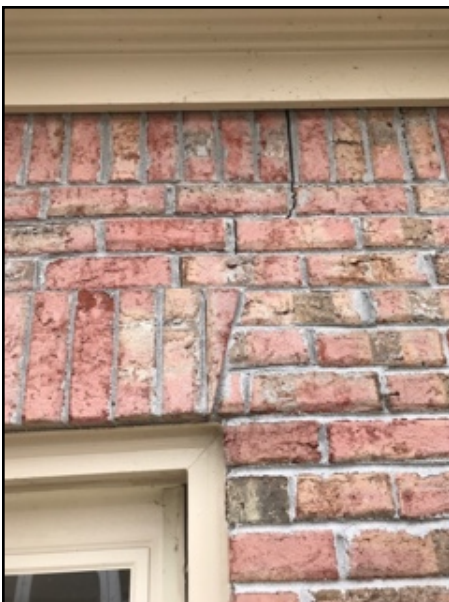
Figure 9-1

There is a crack in the brick above one of the garage doors. The crack does not present a structural concern, but it should be sealed up.

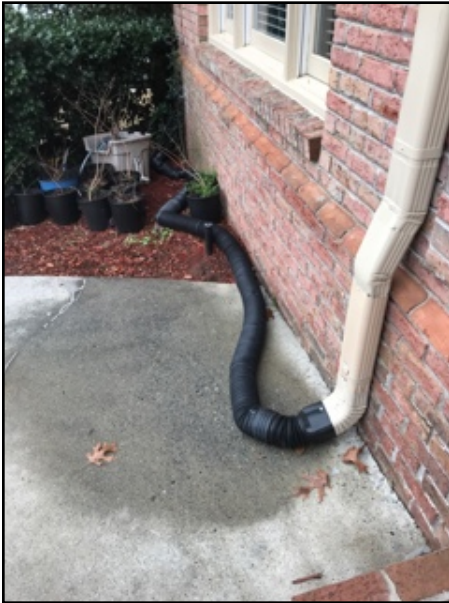
Figure 10-1

There is a gutter pipe near the front door that extends around the left side of the house. The drainage pipe is crushed which will impede the flow of water. I would have the drainage pipe replaced.

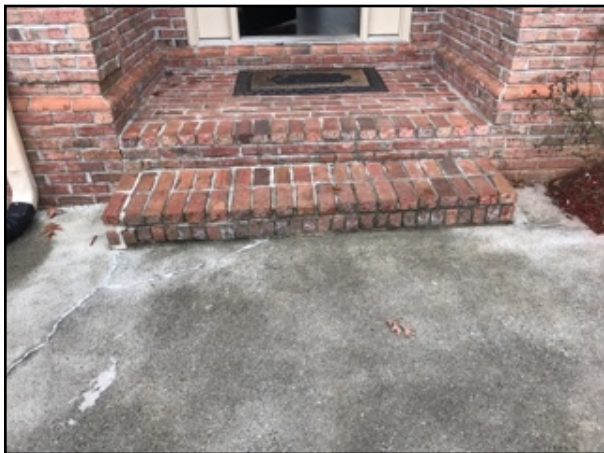
Figure 11-1

The steps at the front door are out of level. Some of the mortar on the left side needs to be repointed to prevent water from getting into the step. In the wintertime this water will freeze and cause further damage.

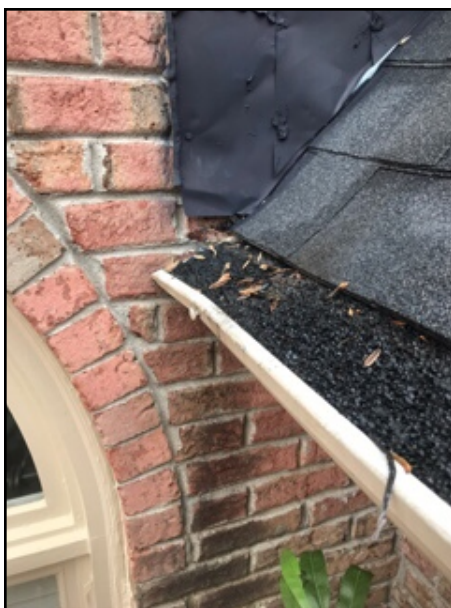
Figure 12-1

There is a stain on the brick, on the deck. The stain indicates that water is leaking behind the gutter and running down the face of the brick. I would have a kick out flashing installed to divert the water into the gutter.

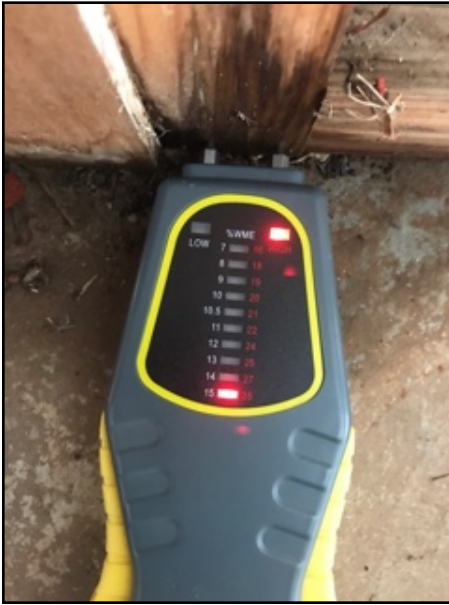
Figure 14-1

There is evidence of moisture intrusion between the garage doors. I would have the exterior of the door and weatherstripping sealed correctly.

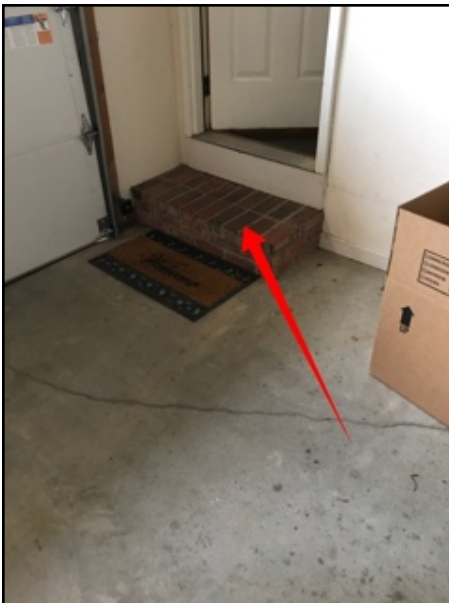
Figure 15-1

The step from the garage into the house is loose. You may be able to carefully raise the step and add an adhesive under it.

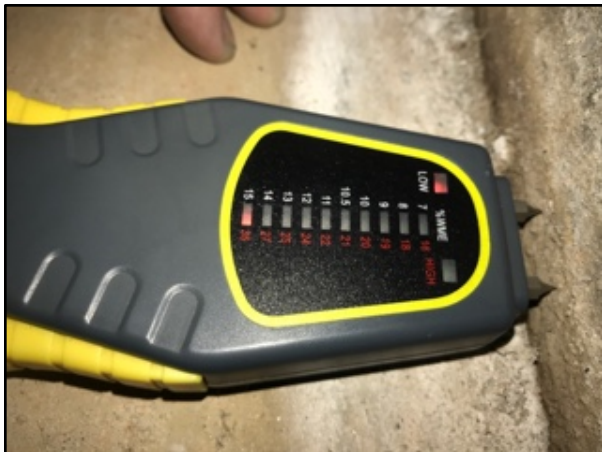
Figure 16-1

There are 3 foundation leaks in the basement. The moisture reading in the areas are higher than the adjacent surfaces. I would recommend further evaluation and correction by a qualified contractor.

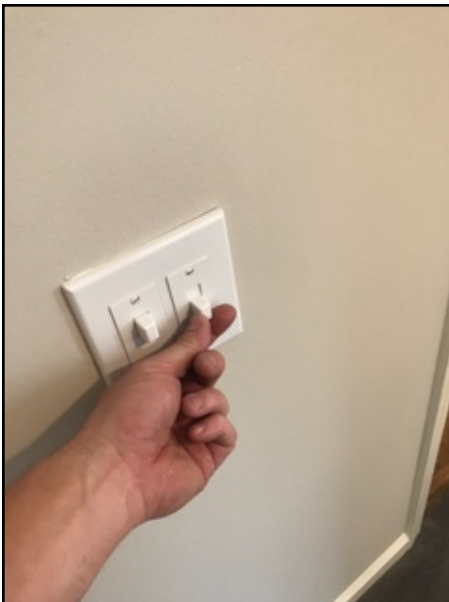
Figure 20-1

The fan switch in the front right bedroom is difficult to operate. The switch works but you might consider having it replaced.

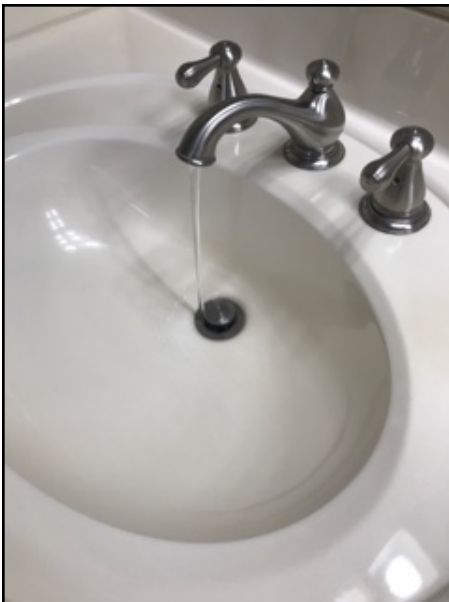
Figure 25-1

**Comment 25:**
The water pressure drops off significantly when multiple fixtures are being used. This may indicate that the pressure reducing valve is going bad. I would recommend further evaluation and correction by a plumber.

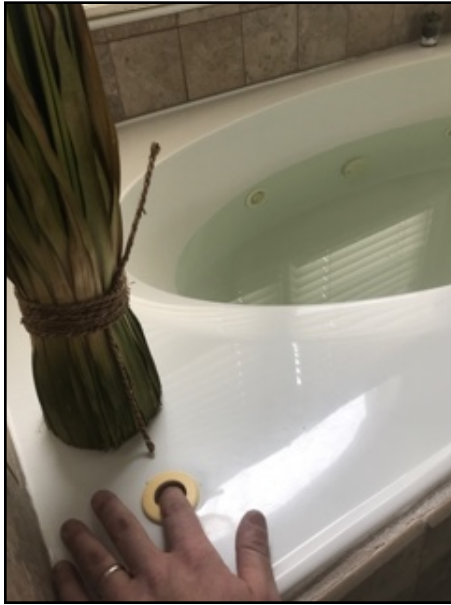
Figure 28-1

The motor on the garden tub would not come on. The switch and GFCI for the tub are located behind the door in the toilet cubby. I would recommend further evaluation and repair by an electrician.

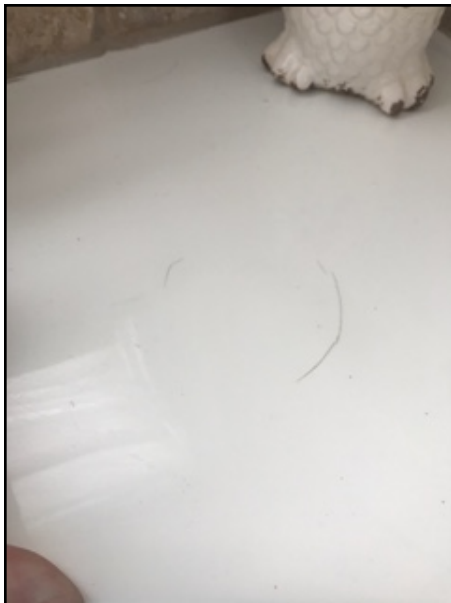
Figure 29-1

There is a small crack in the tub deck. TnT Bathtub Repair in Bethlehem does these kind of repairs.

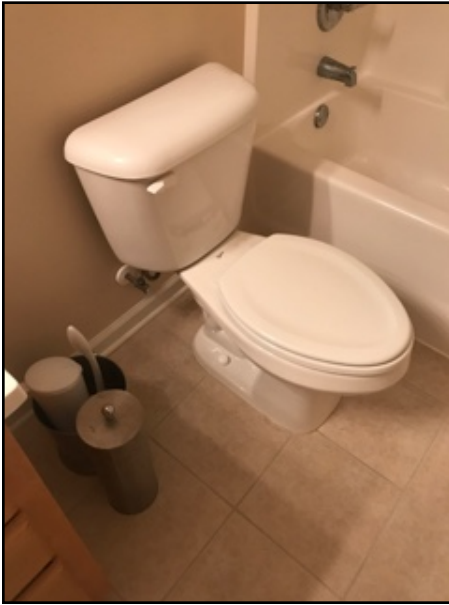
Figure 30-1

The toilet in the basement refills very slowly. I would recommend having a new fill valve installed.

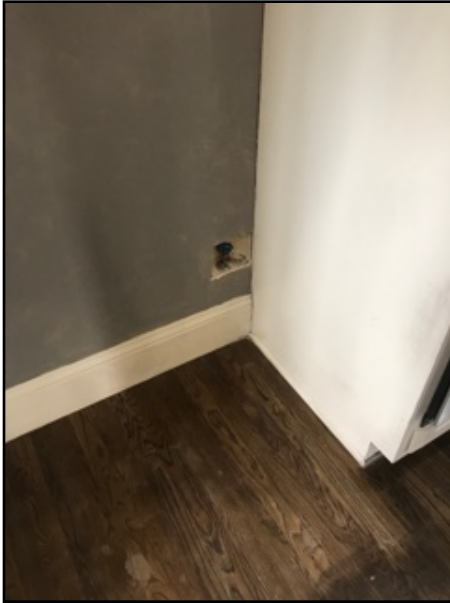
Figure 32-1

The trim plate is missing from the ice maker box.

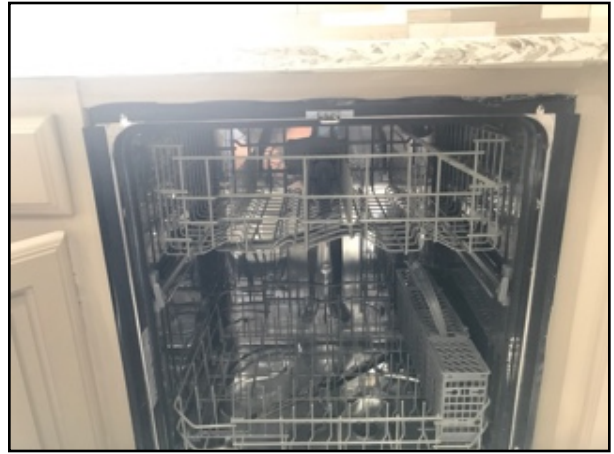
Figure 33-2

21) Comment 33: The dishwasher is not square in the hole and needs to be secured better.

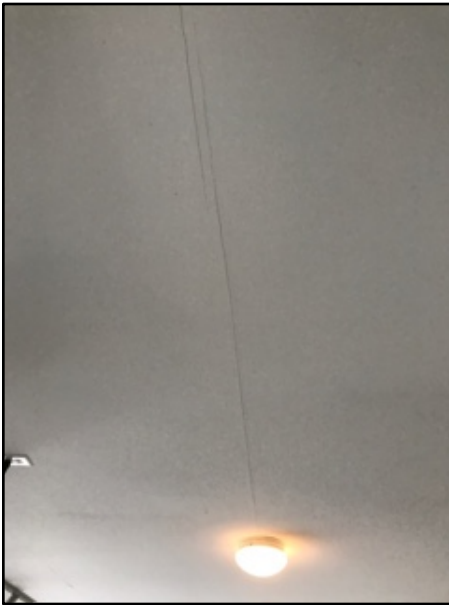
Figure 34-1

There are several places in the interior of the home where the drywall needs to be repaired and re-painted.

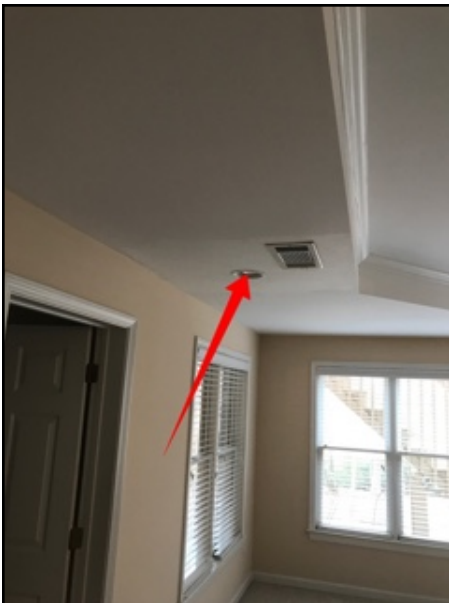
Figure 36-1

A repair has been made to the drywall in one of the downstairs rooms. There is no apparent moisture in the area so I would ask the current owners for an explanation.

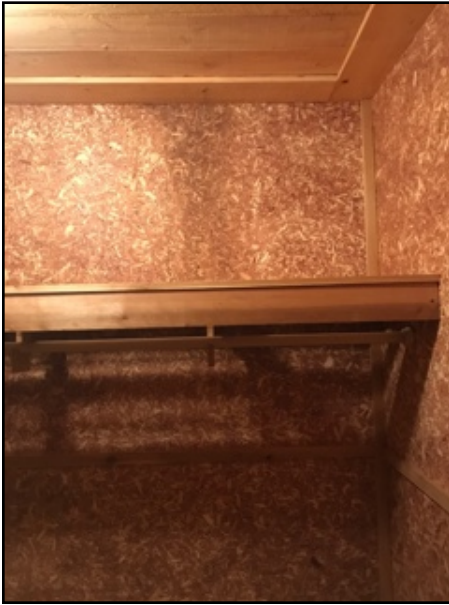
Figure 38-1

There are some water stains in the small room under the master shower. The moisture content of the wood is slightly higher in the stained area. Further evaluation and repair is needed.

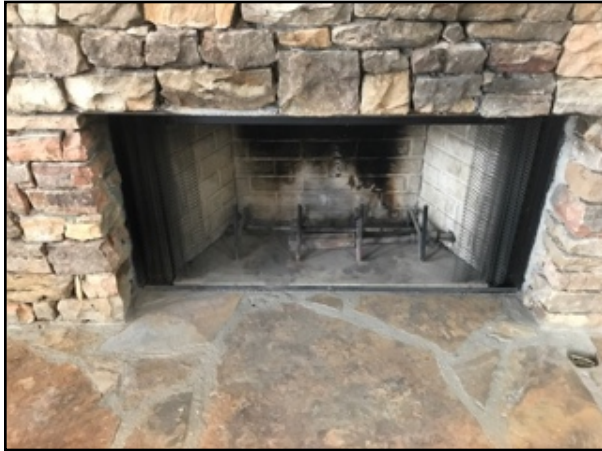
Figure 39-1

The fireplace is a manufactured unit which includes a gas starter. The rear panel has some small cracks and needs to be replaced. The damper is operational and the flue appears to be fairly clean. It is recommended to have the fireplace and flue pipe cleaned and inspected every 12 months. I would recommend having this done prior to closing.
