Blueprint Home Inspection

Home Inspection Report

5309 Easy St

Inspected on Sat, Aug 1 2020 at 1:00 PM

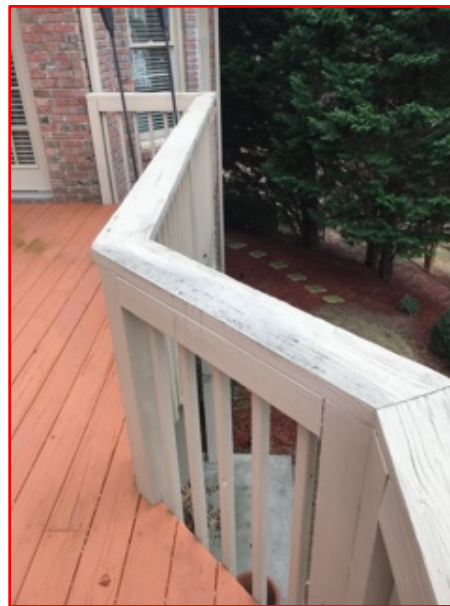
Figure 4-2

1) Comment 4: The paint on the handrail is beginning to deteriorate. I would recommend a fresh coat to seal up the wood fibers and prevent moisture damage.

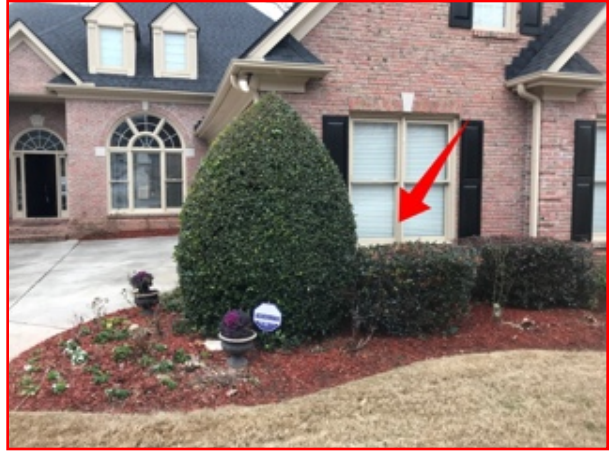
Figure 5-2

2) Comment 5: There are several places around the exterior of the home that need to be repaired, caulked and repainted. Some of the windows have been repaired but further repairs are needed in areas. I would recommend further evaluation and repair by a painting contractor.

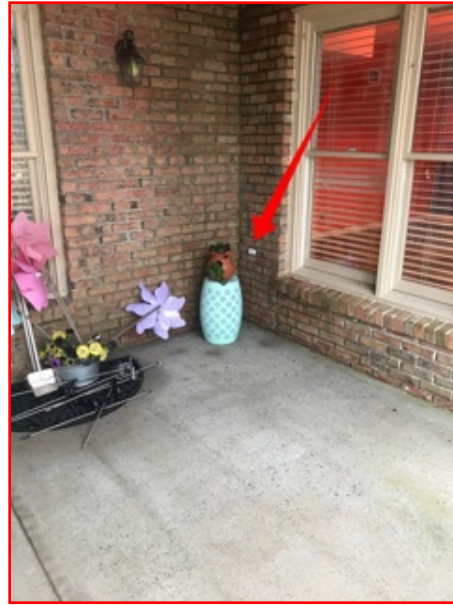
Figure 6-2

3) Comment 6: The outlet on the patio is missing the weatherproof cover.

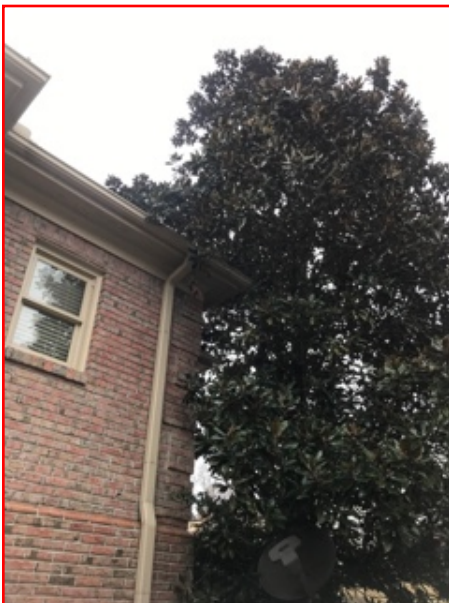
Figure 7-1

4) Comment 7: The tree on the front left corner of the house is coming in contact with the roof. This will significantly decrease the life of the shingles in that area. I would have the tree trimmed back.

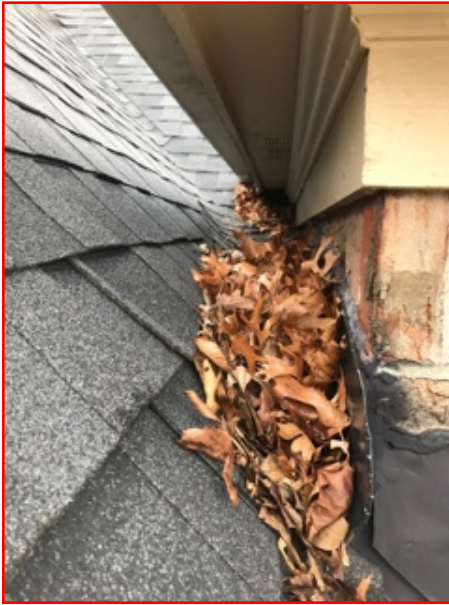
Figure 8-1

5) Comment 8: There is a small section of roof above the front door that has collected leaves and debris. I would have this cleaned out.

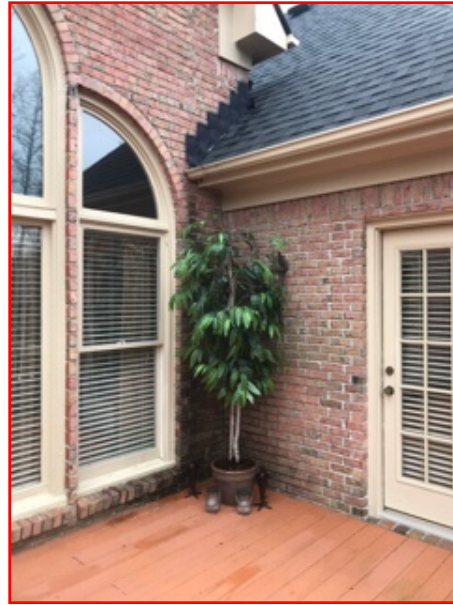
Figure 12-2

9) Comment 12: There is a stain on the brick, on the deck. The stain indicates that water is leaking behind the gutter and running down the face of the brick. I would have a kick out flashing installed to divert the water into the gutter.

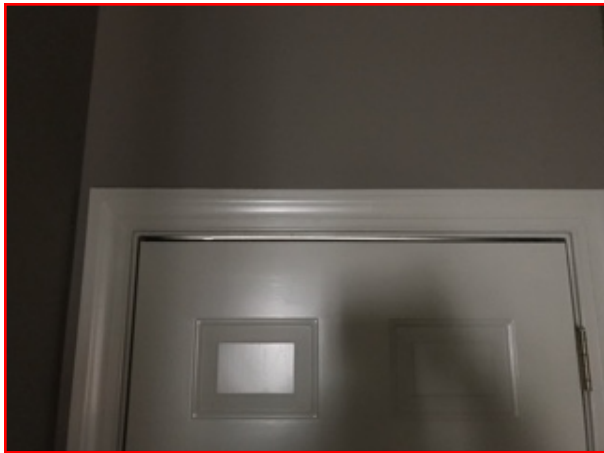
Figure 13-1

10) Comment 13: The door leading into the garage does not seal well against the weatherstripping at the top. I would add additional weatherstripping or adjust the door so that it seals correctly.

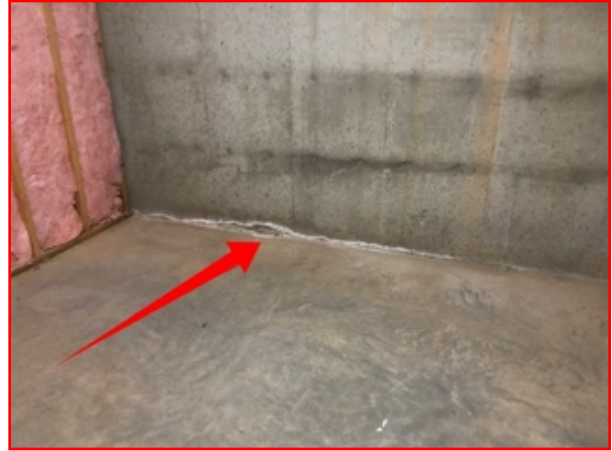
Figure 16-2

13) Comment 16: There are 3 foundation leaks in the basement. The moisture reading in the areas are higher than the adjacent surfaces. I would recommend further evaluation and correction by a qualified contractor.

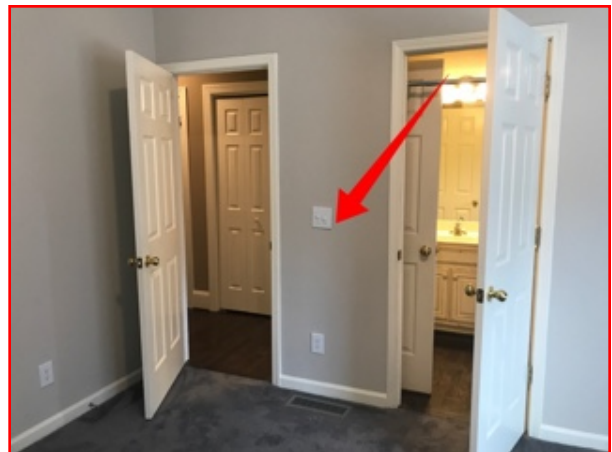
Figure 20-2

14) Comment 20: The fan switch in the front right bedroom is difficult to operate. The switch works but you might consider having it replaced.

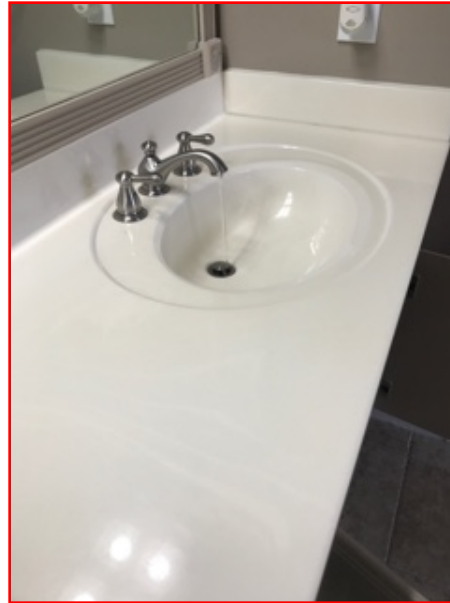
Figure 25-2

15) Comment 25: The water pressure drops off significantly when multiple fixtures are being used. This may indicate that the pressure reducing valve is going bad. I would recommend further evaluation and correction by a plumber.

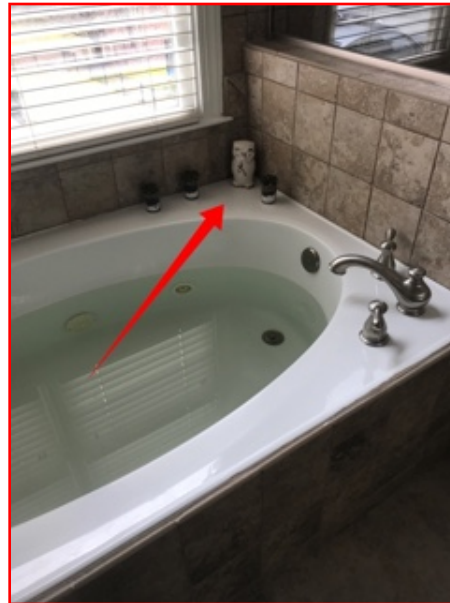
Figure 29-2

17) Comment 29: There is a small crack in the tub deck. TnT Bathtub Repair in Bethlehem does these kind of repairs.

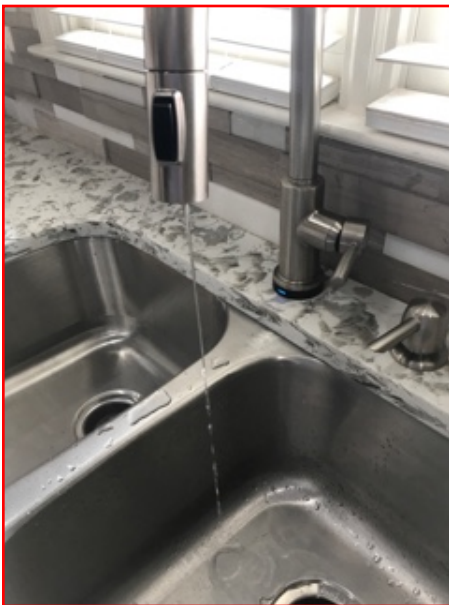
Figure 31-1

19) Comment 31: The volume of hot water through the kitchen faucet is very low. It may be a blockage in the faucet somewhere. I would have the faucet checked by a plumber.

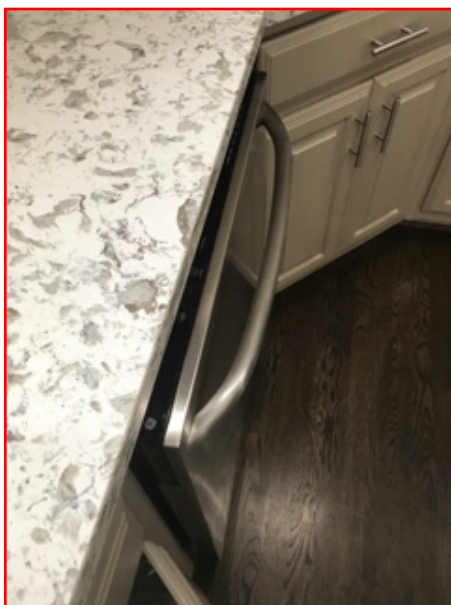
Figure 33-1

21) Comment 33: The dishwasher is not square in the hole and needs to be secured better.

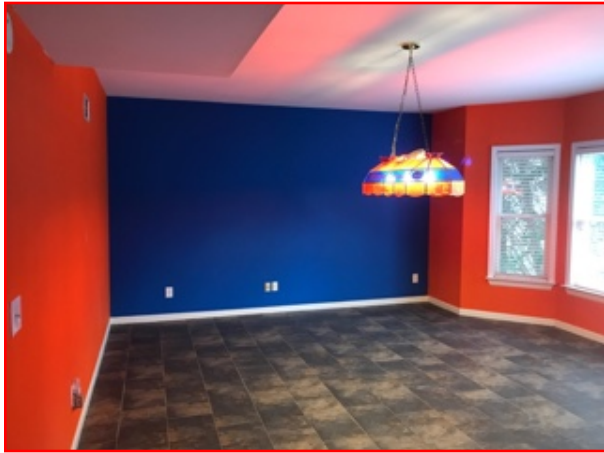
Figure 35-1

23) Comment 35: The game room at the bottom of the stairs needs to be repainted. The orange and blue color combination is visually offensive, and if not corrected, may cause you too grow your hair out (only in the back) and cut off all your jeans below the knee. I would encourage you to select a color scheme that includes more red and black. Go Dawgs!!

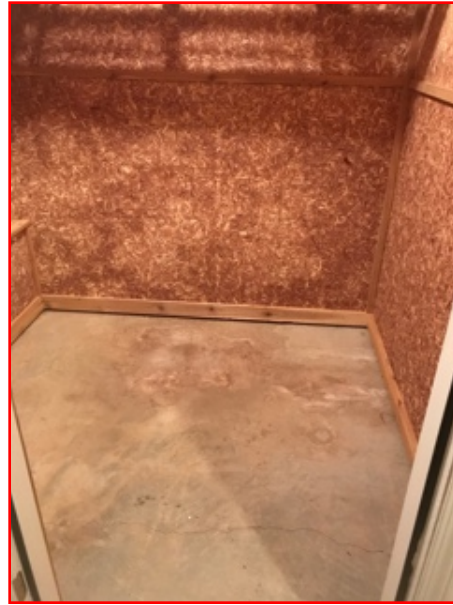
Figure 38-1

26) Comment 38: There are some water stains in the small room under the master shower. The moisture content of the wood is slightly higher in the stained area. Further evaluation and repair is needed.

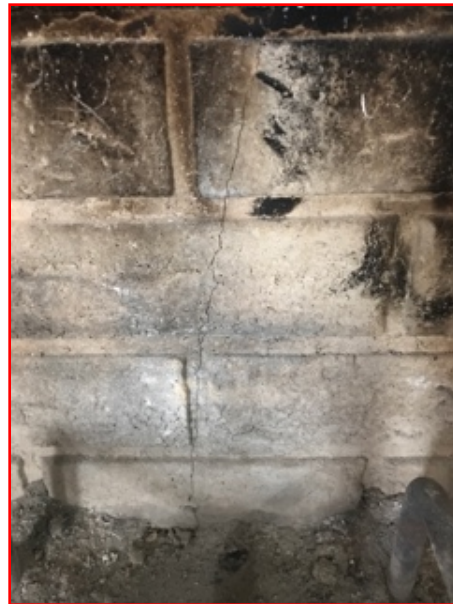
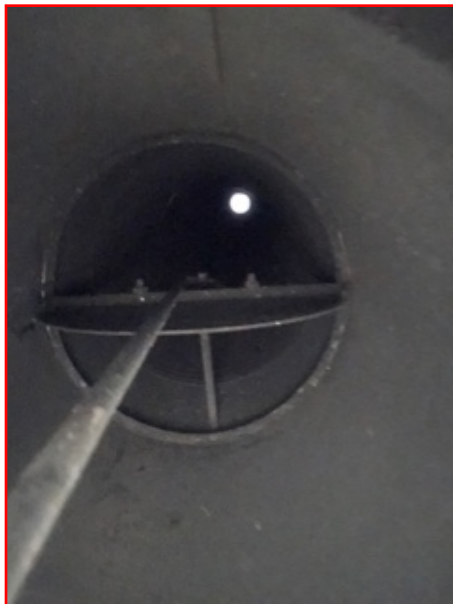
27) Comment 39: The fireplace is a manufactured unit which includes a gas starter. The rear panel has some small cracks and needs to be replaced. The damper is operational and the flue appears to be fairly clean. It is recommended to have the fireplace and flue pipe cleaned and inspected every 12 months. I would recommend having this done prior to closing.

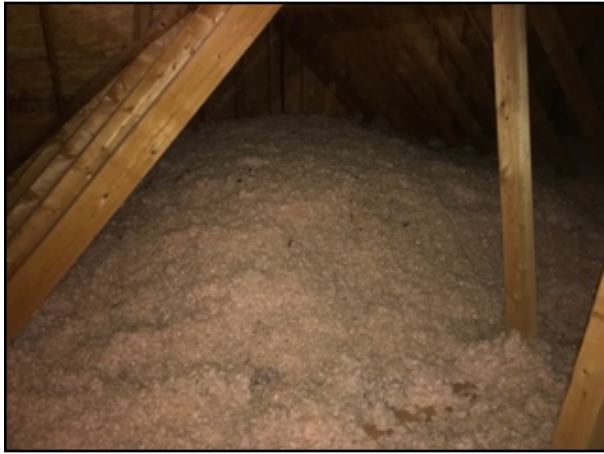
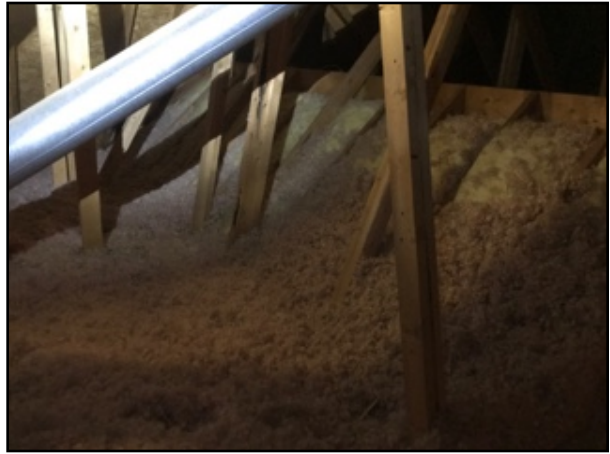
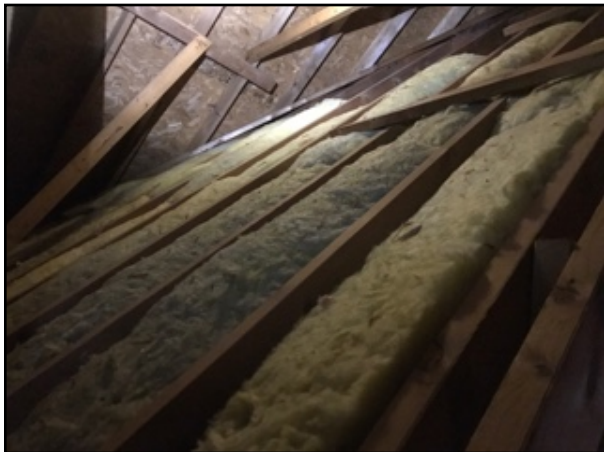
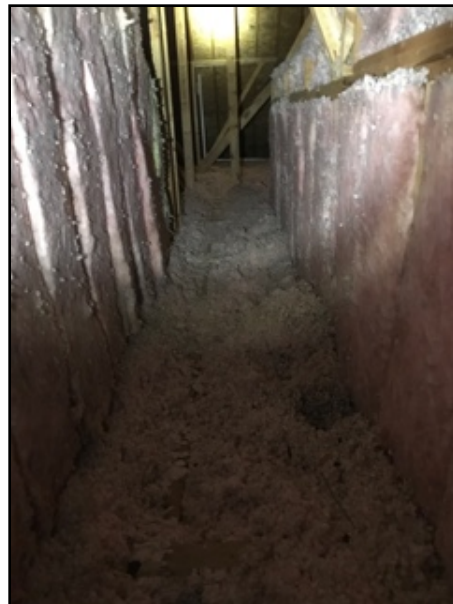
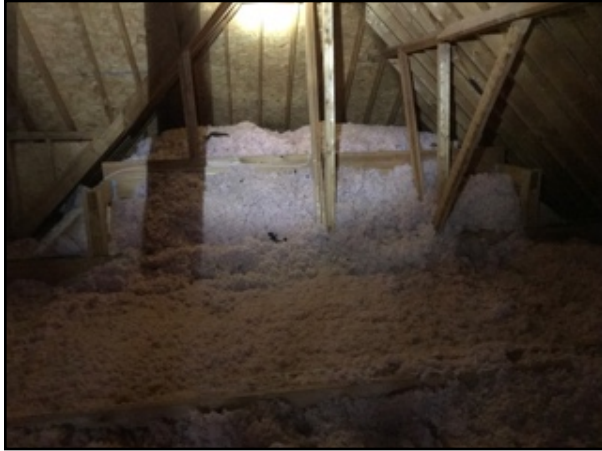
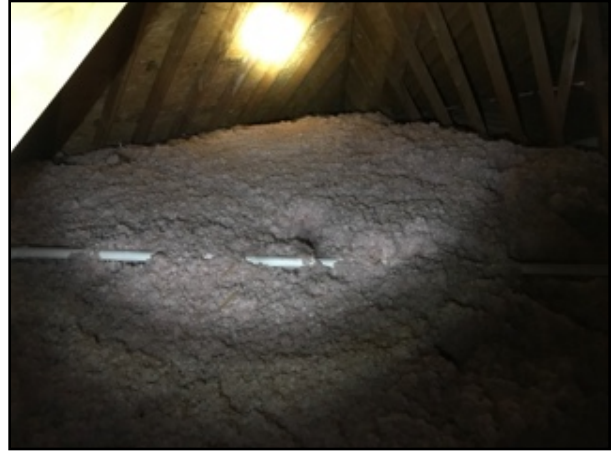
The attic insulation is in good condition and is adequate throughout the space.

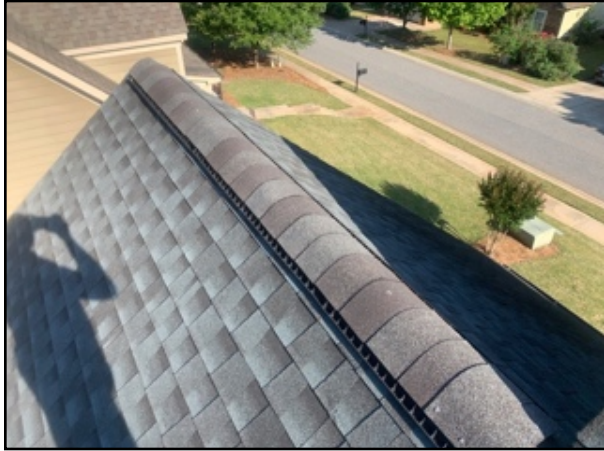
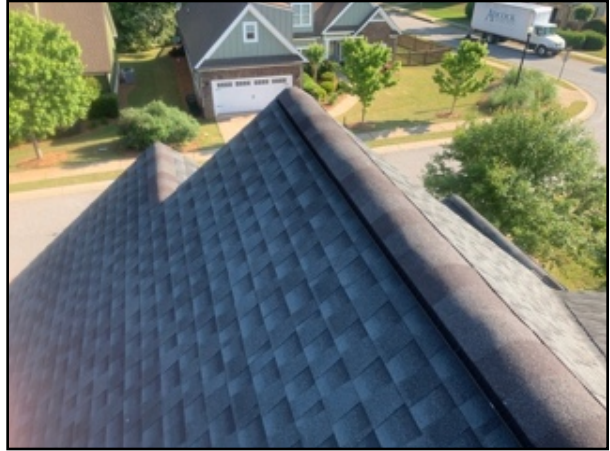
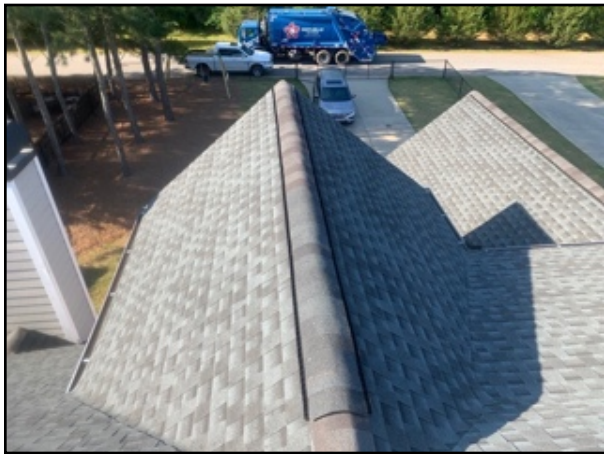
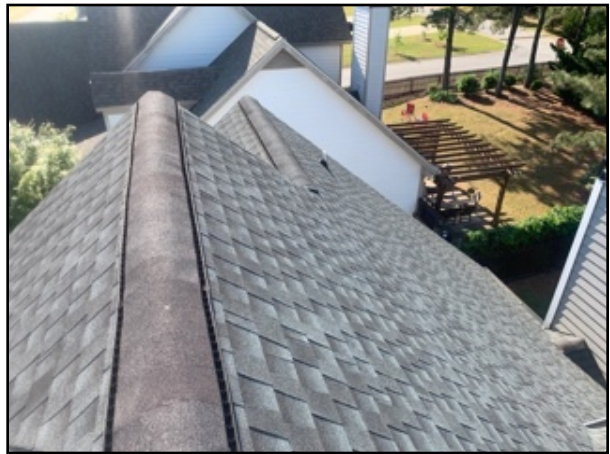
The roof is a fiberglass architectural shingle. The shingles are in good condition and the roof is adequately ventilated.

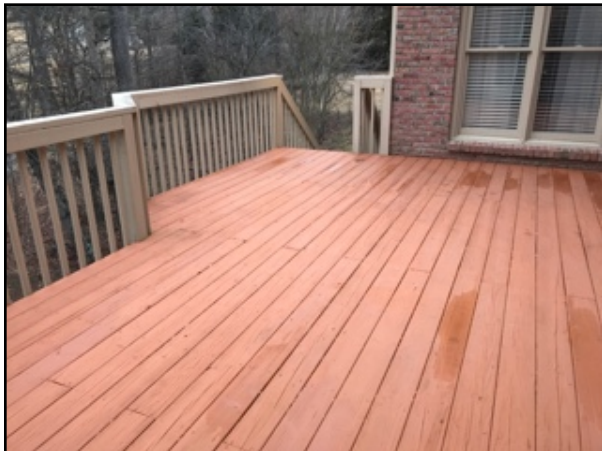
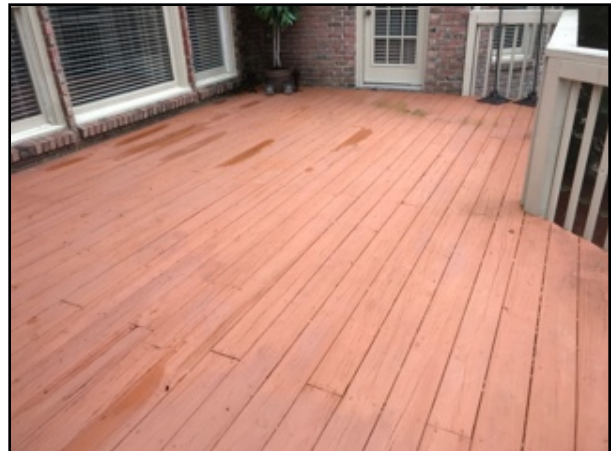
The deck appears to be in good structural condition. The walking surface is sound and no repairs are needed at this time.

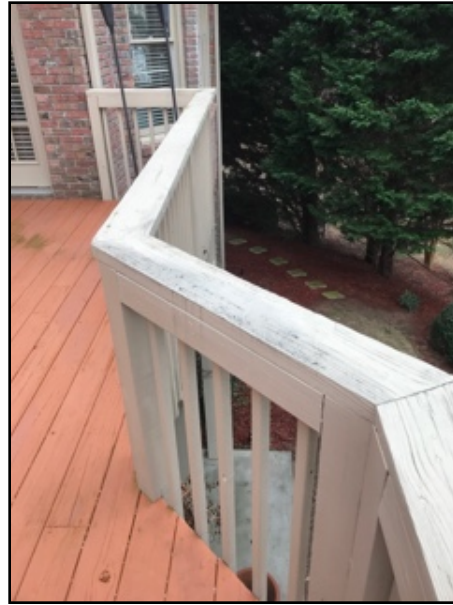
Figure 4-2

The paint on the handrail is beginning to deteriorate. I would recommend a fresh coat to seal up the wood fibers and prevent moisture damage.

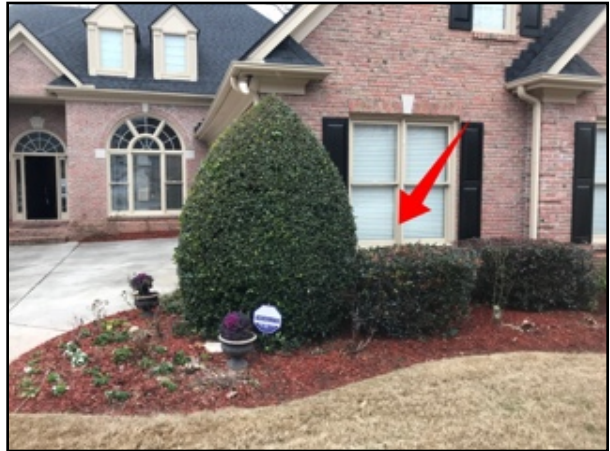
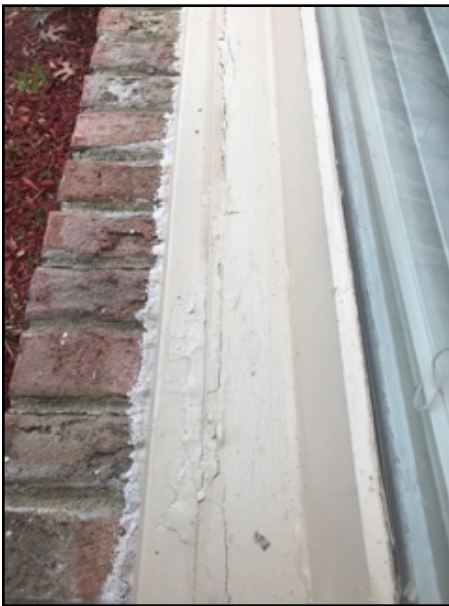
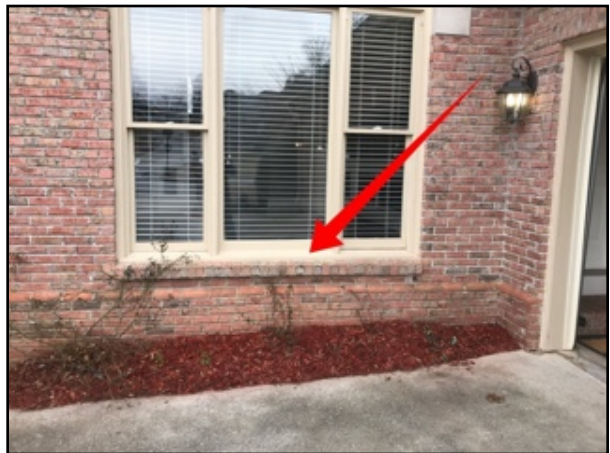
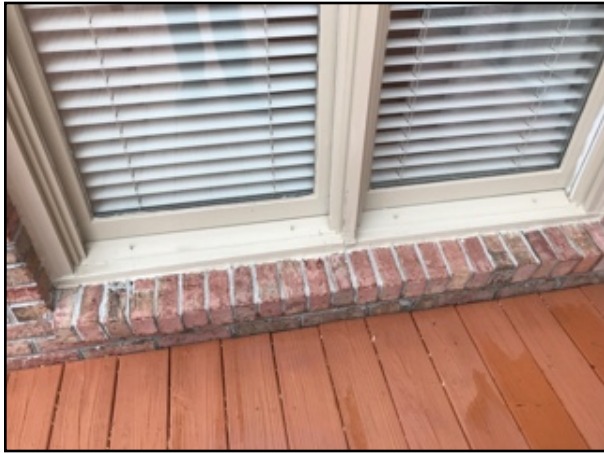
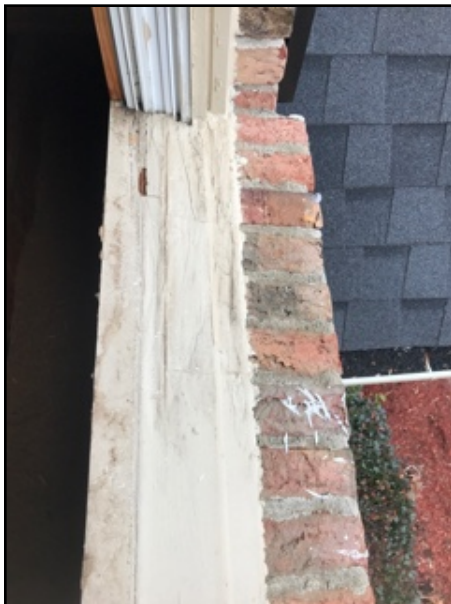
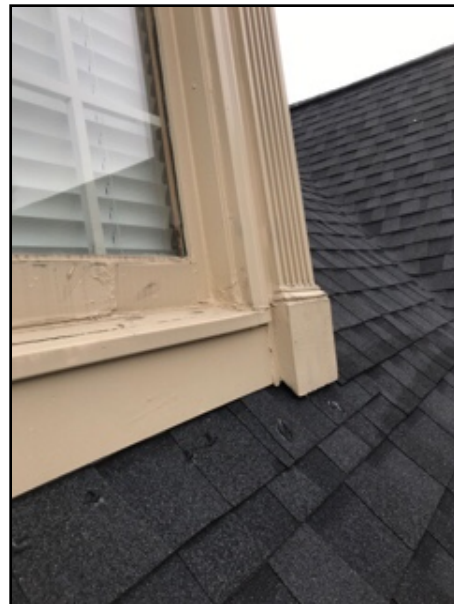
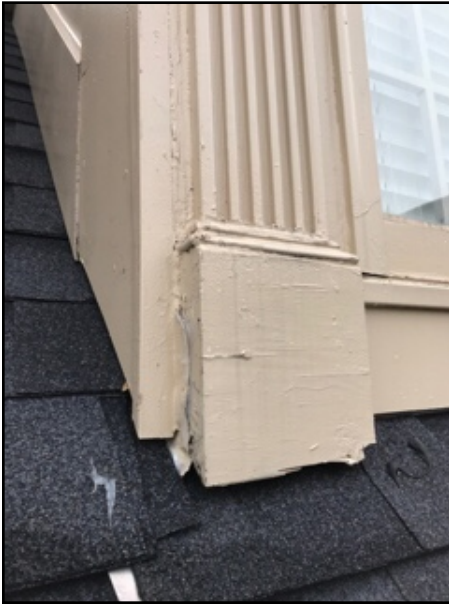
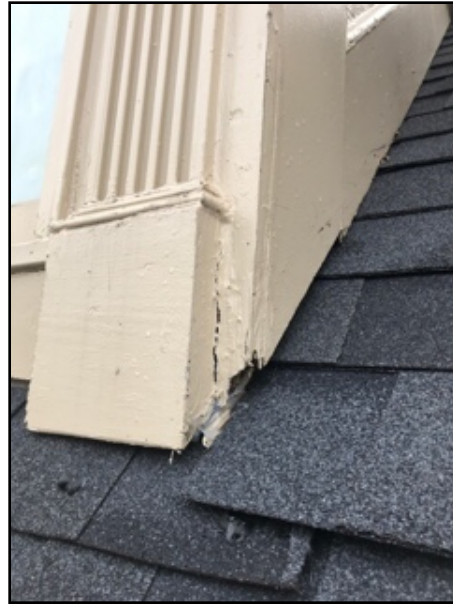
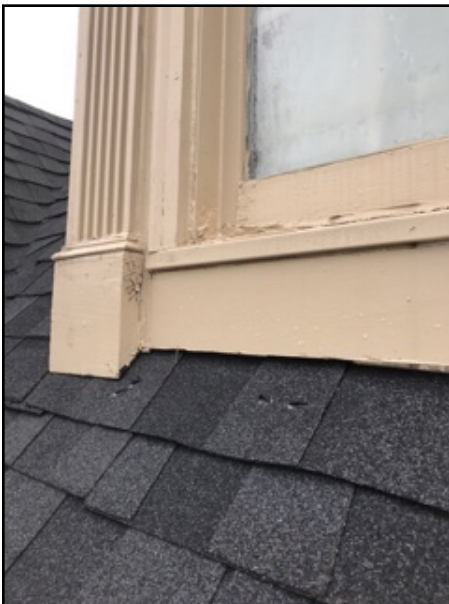
There are several places around the exterior of the home that need to be repaired, caulked and repainted. Some of the windows have been repaired but further repairs are needed in areas. I would recommend further evaluation and repair by a painting contractor.

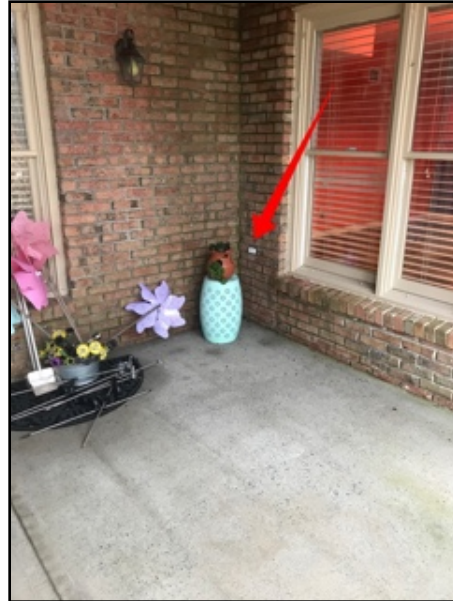
Figure 6-2

The outlet on the patio is missing the weatherproof cover.

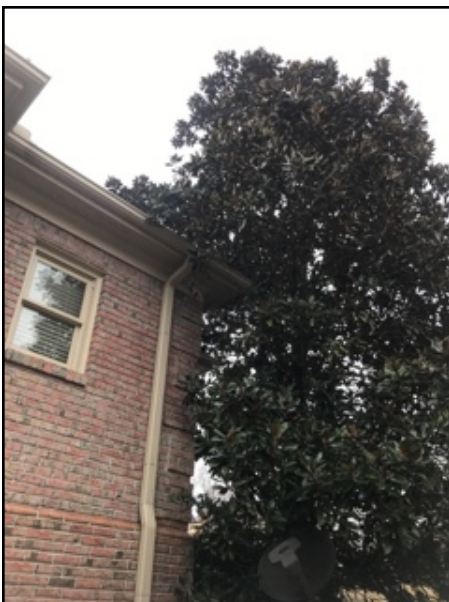
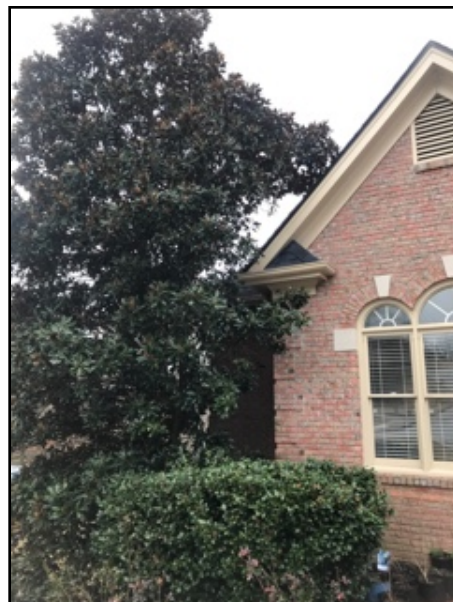
The tree on the front left corner of the house is coming in contact with the roof. This will significantly decrease the life of the shingles in that area. I would have the tree trimmed back.

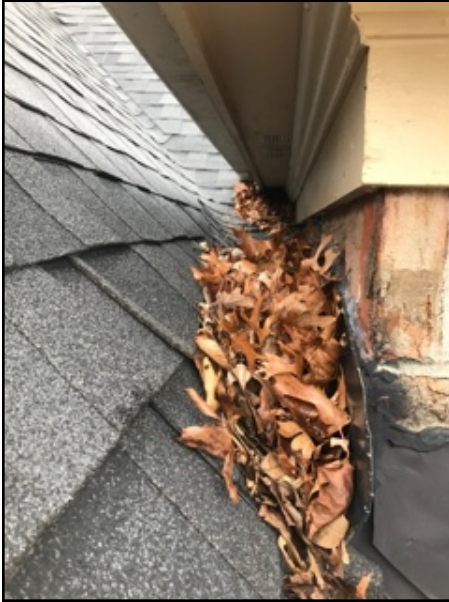
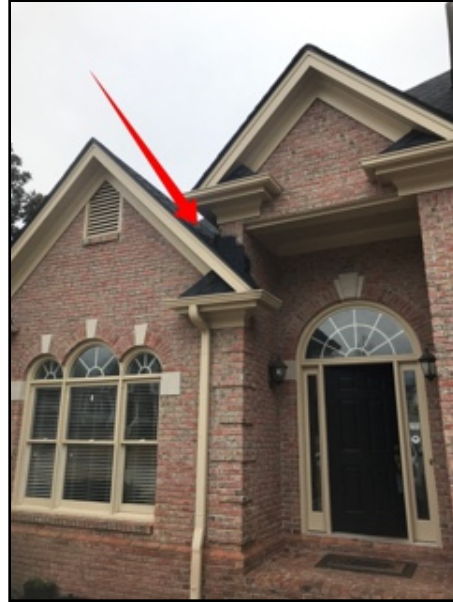
There is a small section of roof above the front door that has collected leaves and debris. I would have this cleaned out.

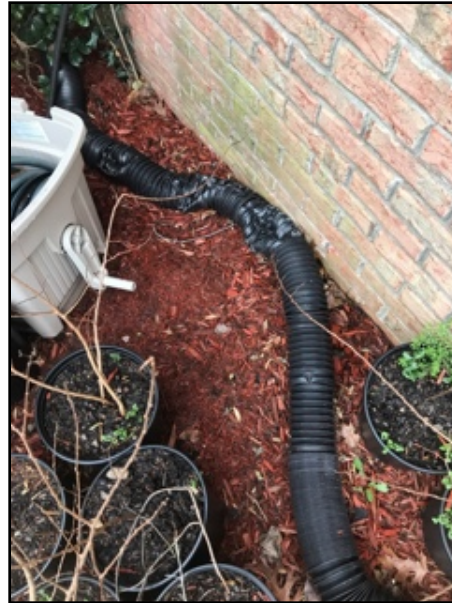
Figure 10-2

There is a gutter pipe near the front door that extends around the left side of the house. The drainage pipe is crushed which will impede the flow of water. I would have the drainage pipe replaced.

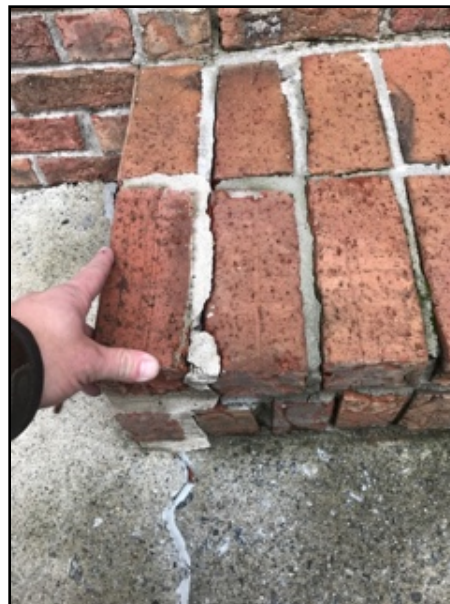
Figure 11-2

The steps at the front door are out of level. Some of the mortar on the left side needs to be repointed to prevent water from getting into the step. In the wintertime this water will freeze and cause further damage.

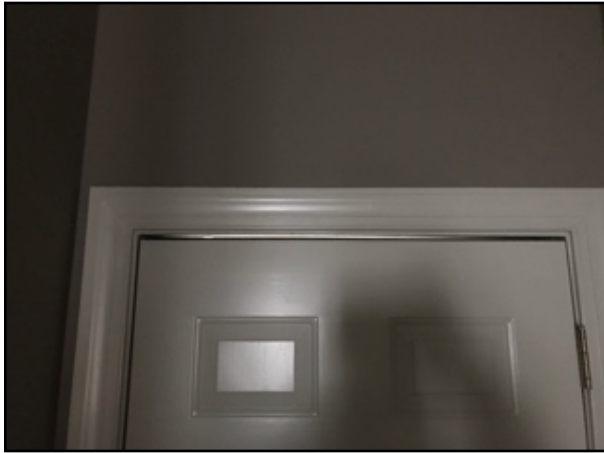
Figure 13-1

The door leading into the garage does not seal well against the weatherstripping at the top. I would add additional weatherstripping or adjust the door so that it seals correctly.

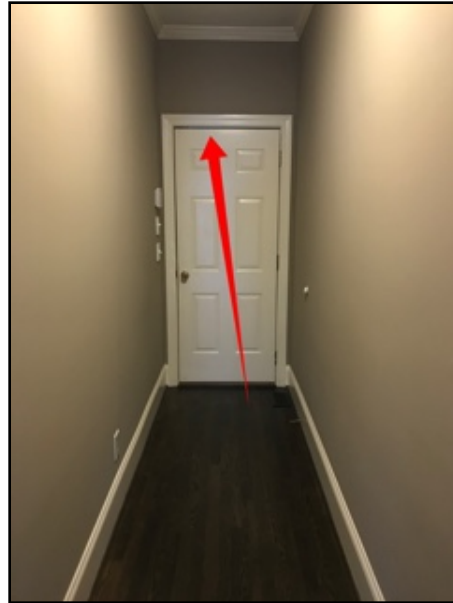
There is evidence of moisture intrusion between the garage doors. I would have the exterior of the door and weatherstripping sealed correctly.

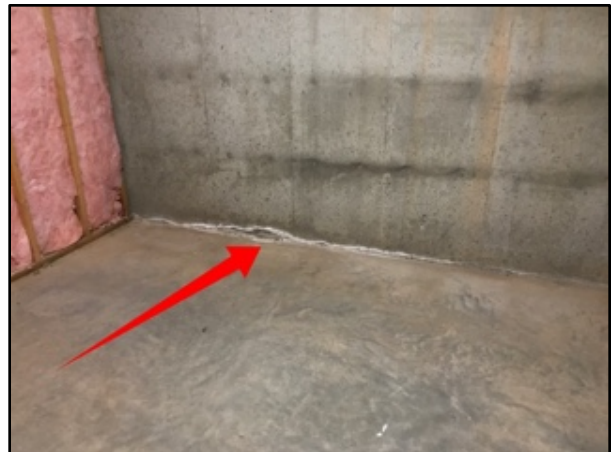
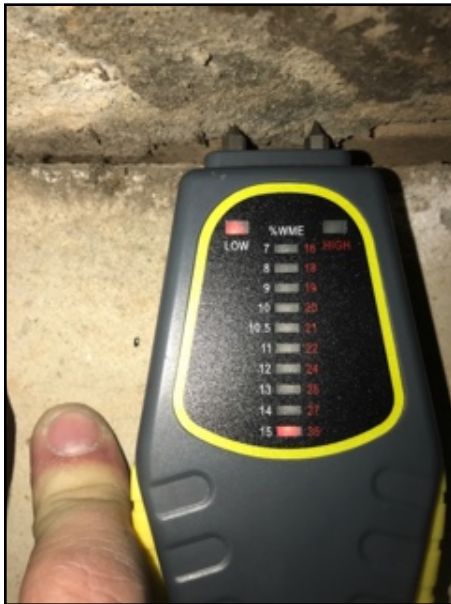
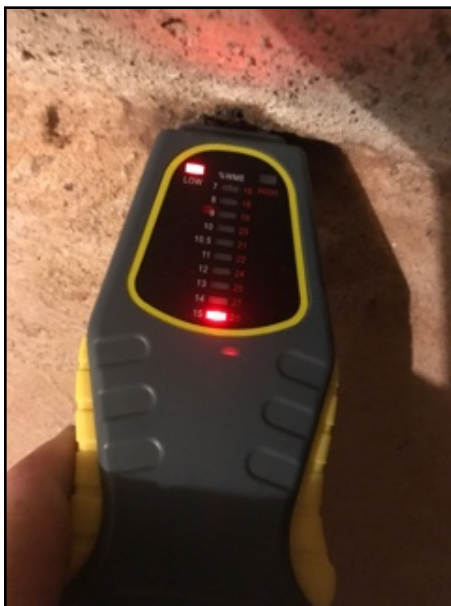
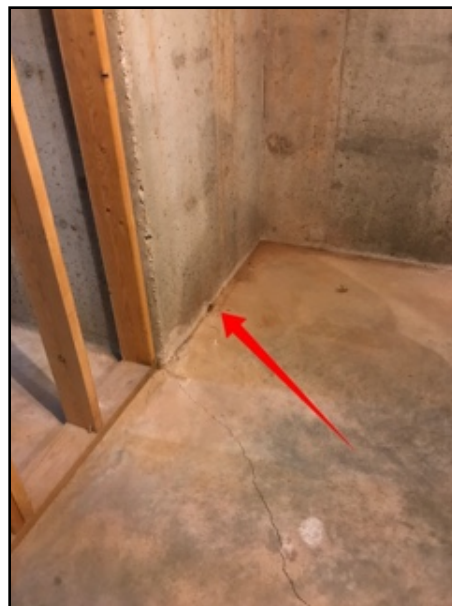
There are 3 foundation leaks in the basement. The moisture reading in the areas are higher than the adjacent surfaces. I would recommend further evaluation and correction by a qualified contractor.

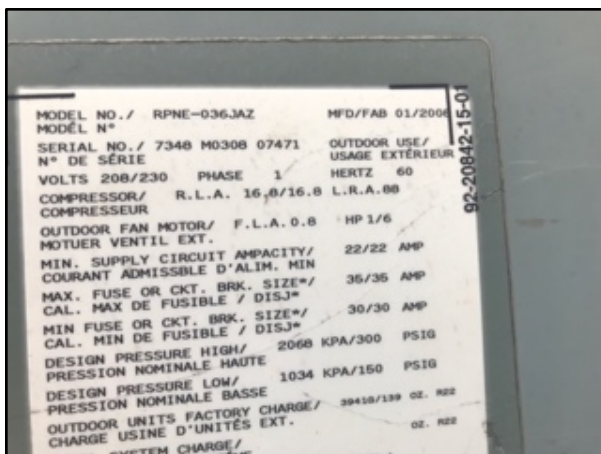
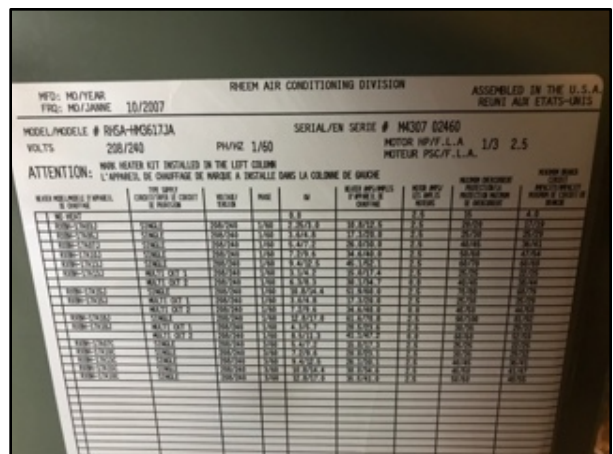
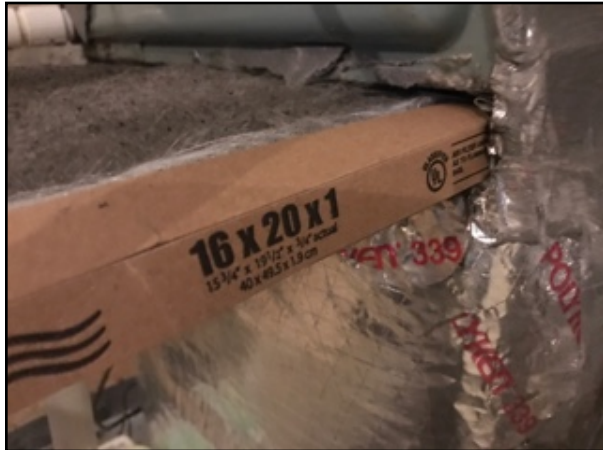
The basement is heated and cooled by 3 ton heat pump. The equipment is approximately 12 years old and appears to be adequately sized for the space. The equipment was working properly at the time of inspection.

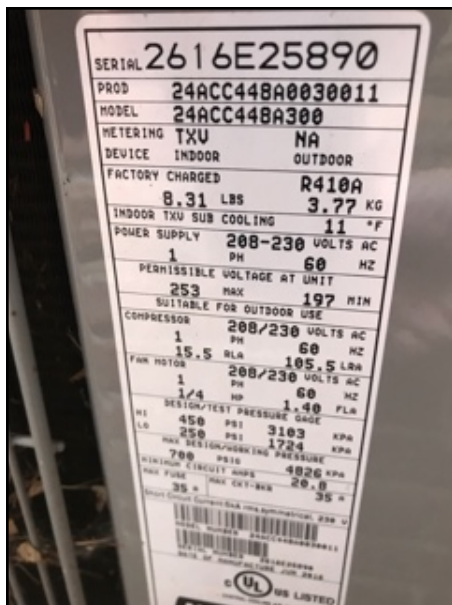
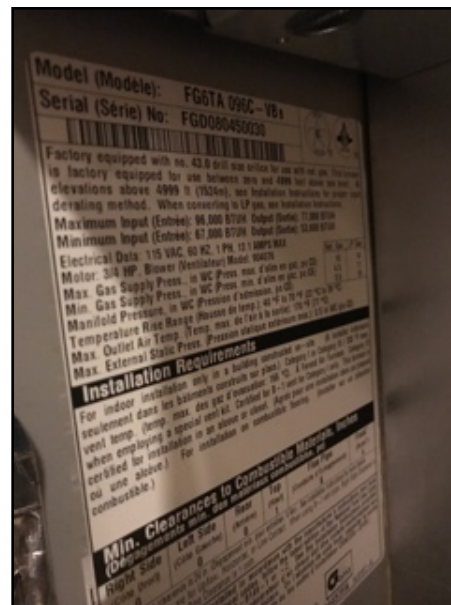
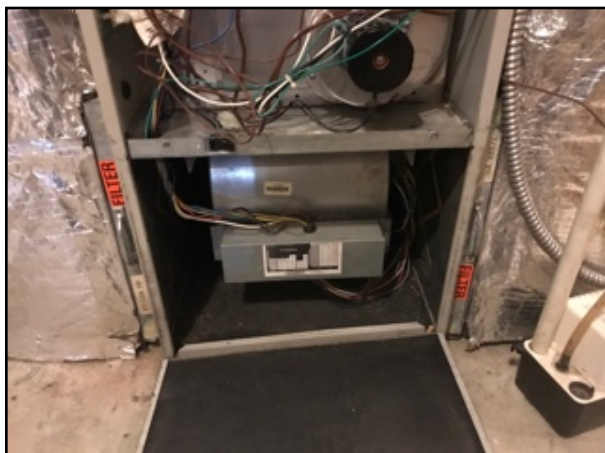
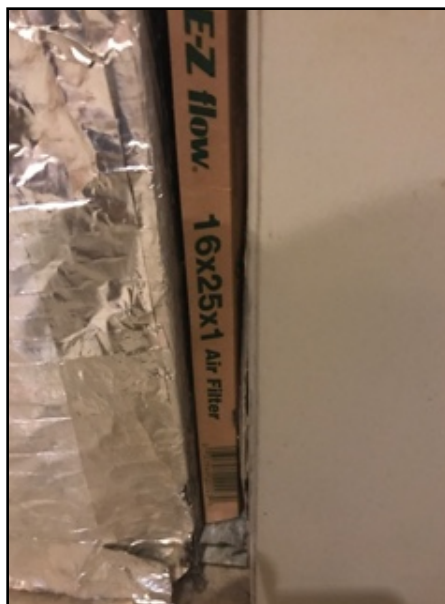
The main level is heated by a 96,000 BTU furnace and cooled by a 4 ton AC. The AC unit is only a year old and the furnace is approximately 12 years old. The equipment appears to be adequately sized and it was working properly at the time of inspection.

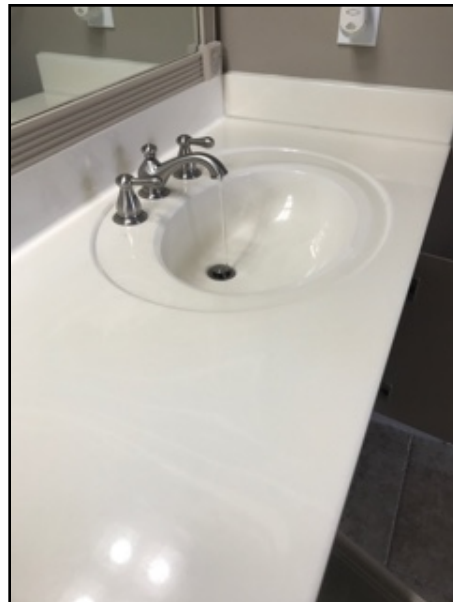
Figure 25-2

**Comment 25:**
The water pressure drops off significantly when multiple fixtures are being used. This may indicate that the pressure reducing valve is going bad. I would recommend further evaluation and correction by a plumber.

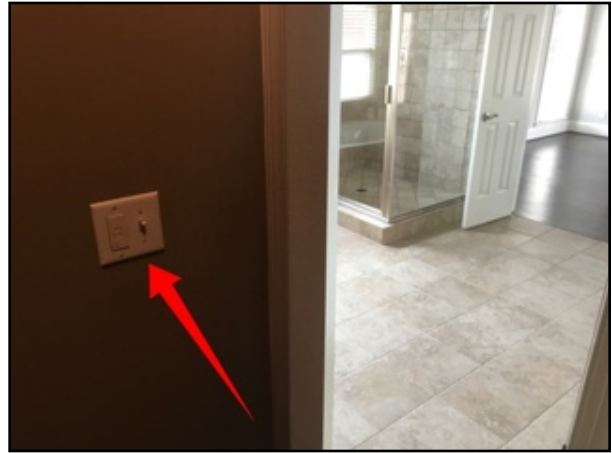
Figure 28-2

The motor on the garden tub would not come on. The switch and GFCI for the tub are located behind the door in the toilet cubby. I would recommend further evaluation and repair by an electrician.

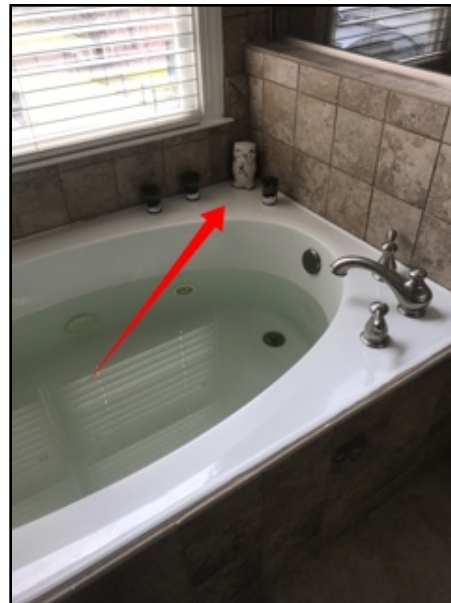
Figure 29-2

There is a small crack in the tub deck. TnT Bathtub Repair in Bethlehem does these kind of repairs.

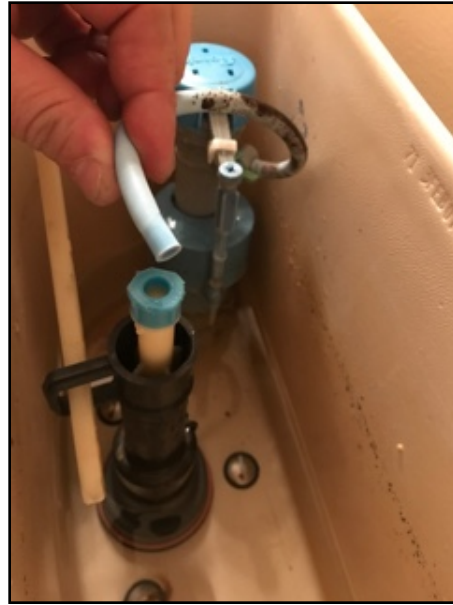
Figure 30-2

The toilet in the basement refills very slowly. I would recommend having a new fill valve installed.

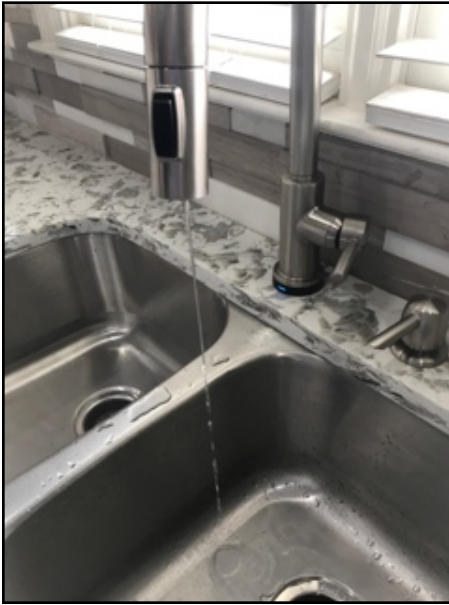
Figure 31-1

The volume of hot water through the kitchen faucet is very low. It may be a blockage in the faucet somewhere. I would have the faucet checked by a plumber.

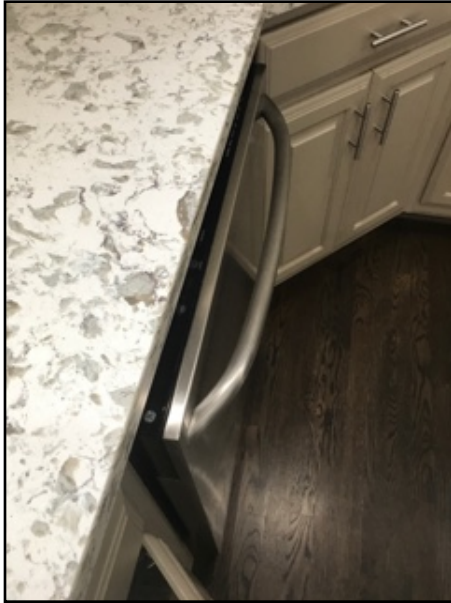
Figure 33-1

The dishwasher is not square in the hole and needs to be secured better.

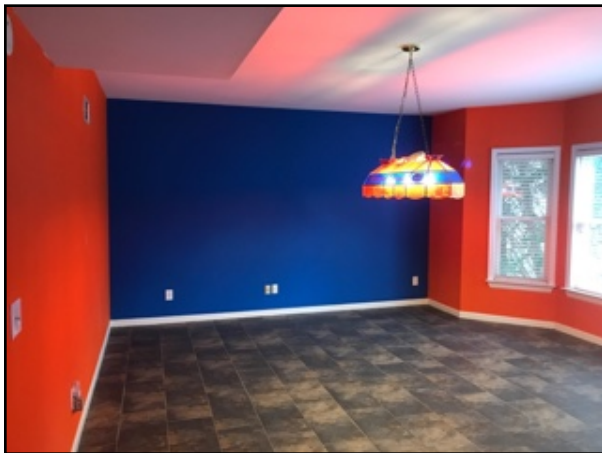
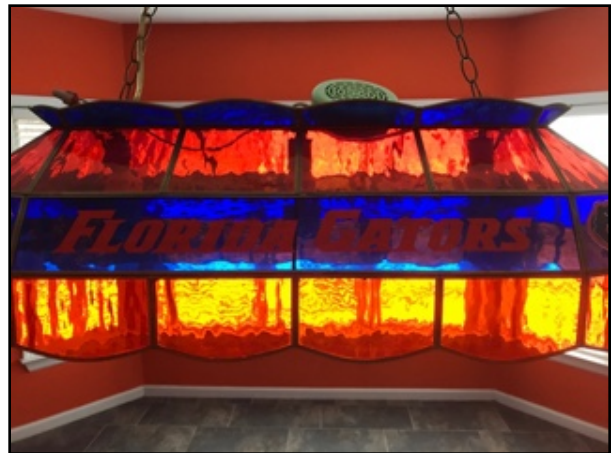
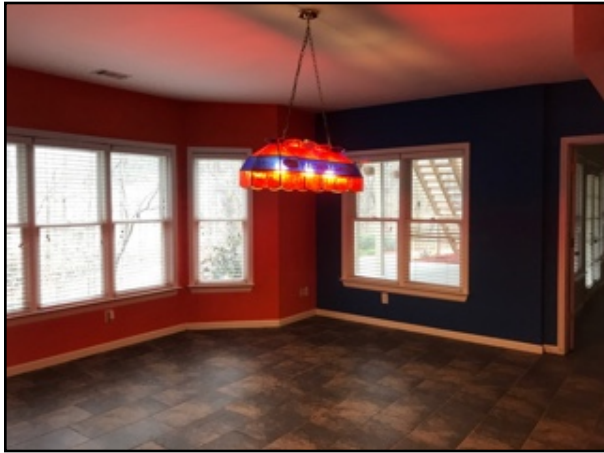
The game room at the bottom of the stairs needs to be repainted. The orange and blue color combination is visually offensive, and if not corrected, may cause you too grow your hair out (only in the back) and cut off all your jeans below the knee. I would encourage you to select a color scheme that includes more red and black. Go Dawgs!!

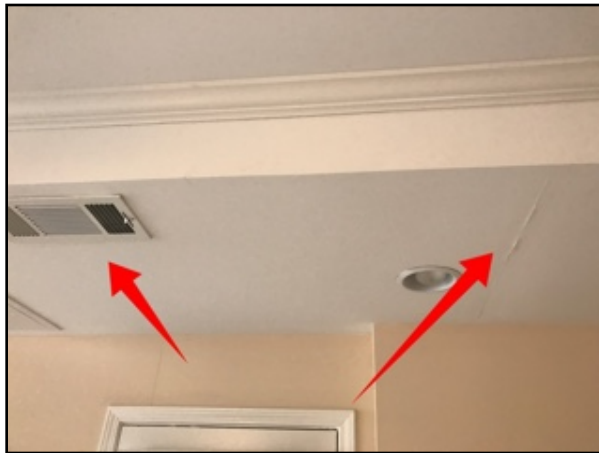
Figure 37-2

There are a couple of water stains on the ceiling under the kitchen sink. There was no apparent moisture in the area at the time of inspection. I would ask the current owners for an explanation.

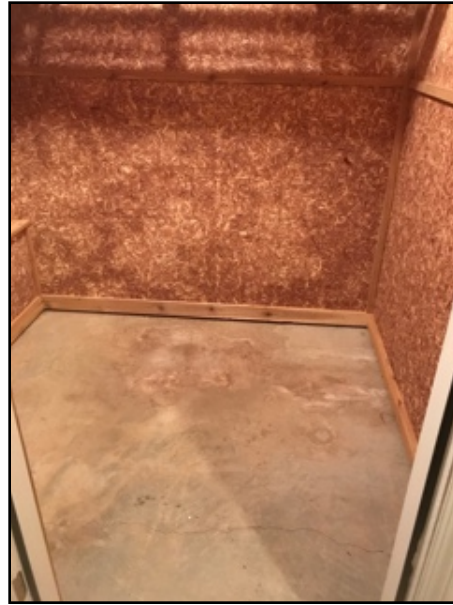
Figure 38-2

There are some water stains in the small room under the master shower. The moisture content of the wood is slightly higher in the stained area. Further evaluation and repair is needed.

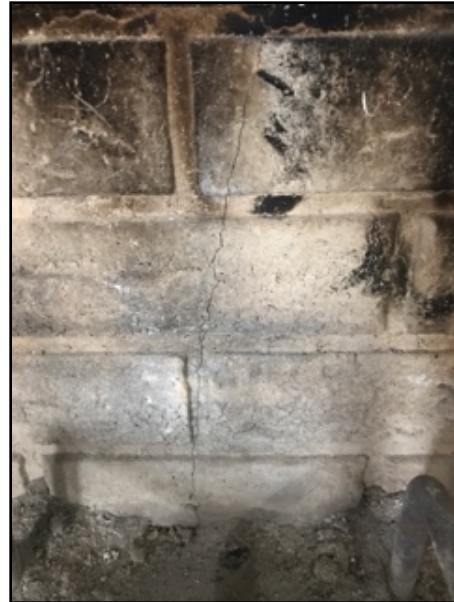
Figure 39-2

The fireplace is a manufactured unit which includes a gas starter. The rear panel has some small cracks and needs to be replaced. The damper is operational and the flue appears to be fairly clean. It is recommended to have the fireplace and flue pipe cleaned and inspected every 12 months. I would recommend having this done prior to closing.
